**2006 EAST END BEACH RESTORATION PROJECT
KIAWAH ISLAND SOUTH CAROLINA**

**Survey Report No 5
May 2012**

SURVEY REPORT NO 5
Annual Beach and Inshore Surveys

[CSE 2258YR5]
May 2012

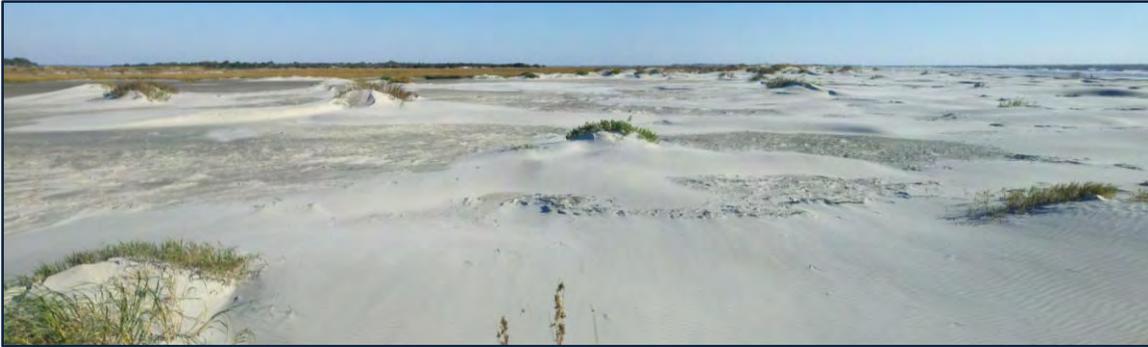
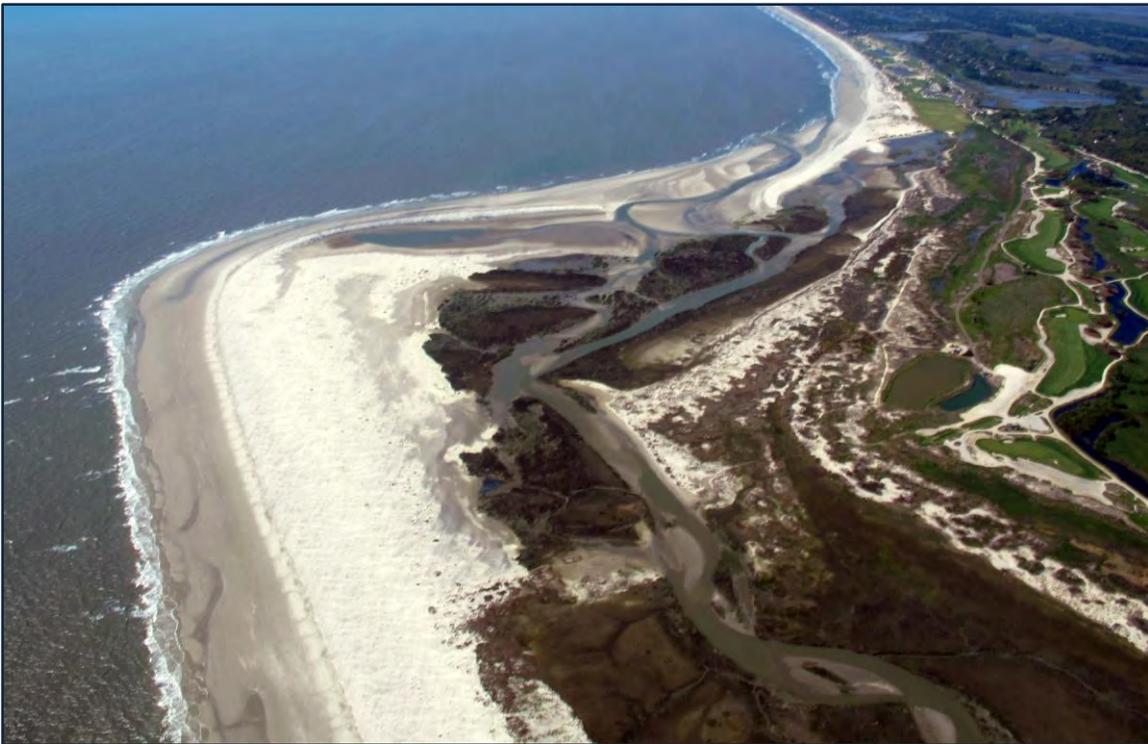
COVER PHOTOS:

[UPPER] Ground photo from station 148+00 looking northeast in October 2011.

[LOWER] Aerial image of the eastern end and Ocean Course taken April 2011. [Photo by TW Kana]

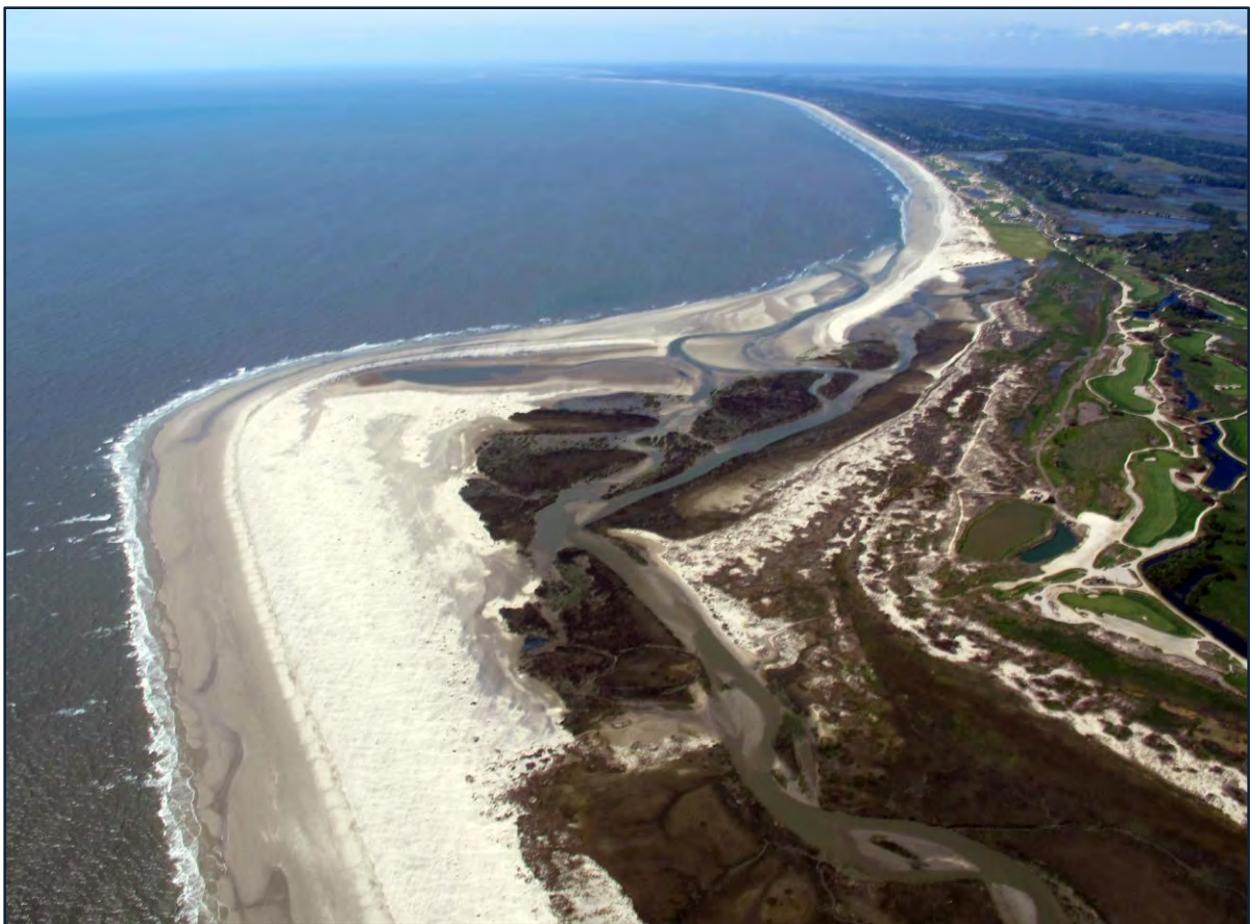
FIGURE 2.1. Kiawah Island's oceanfront at low tide on 15 April 2011. View is toward the west from Stono Inlet. [Photo by T Kana]

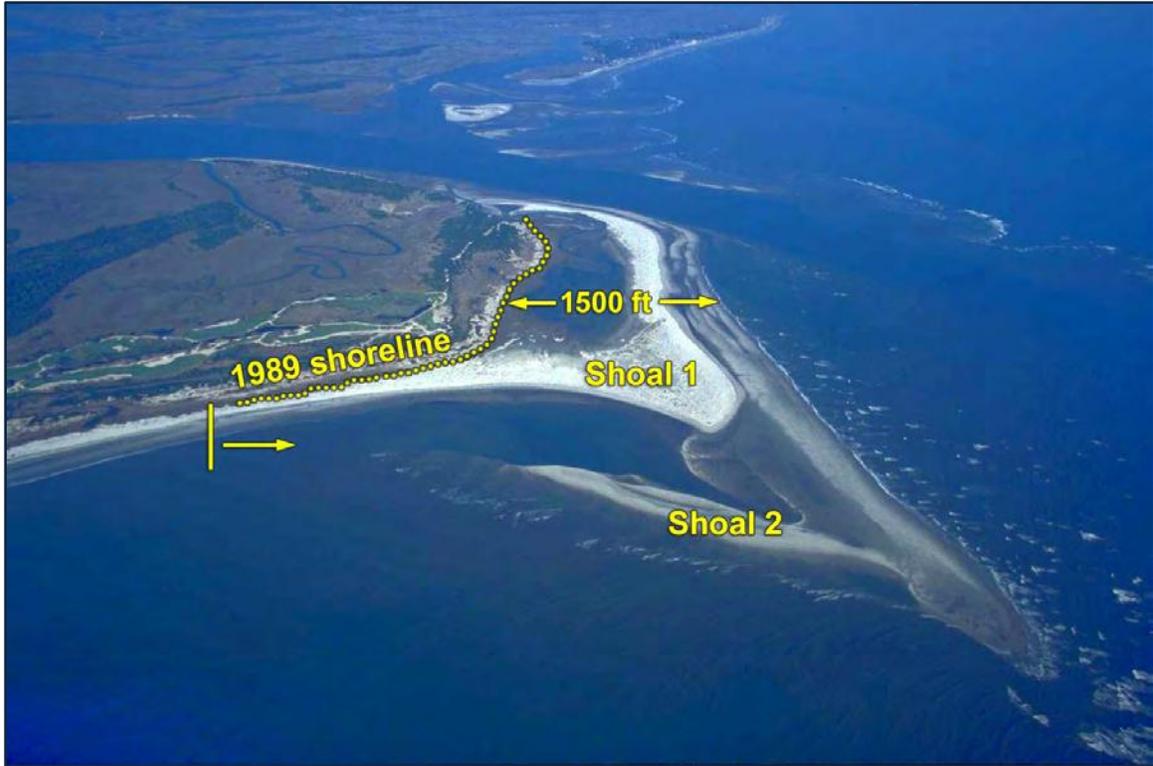
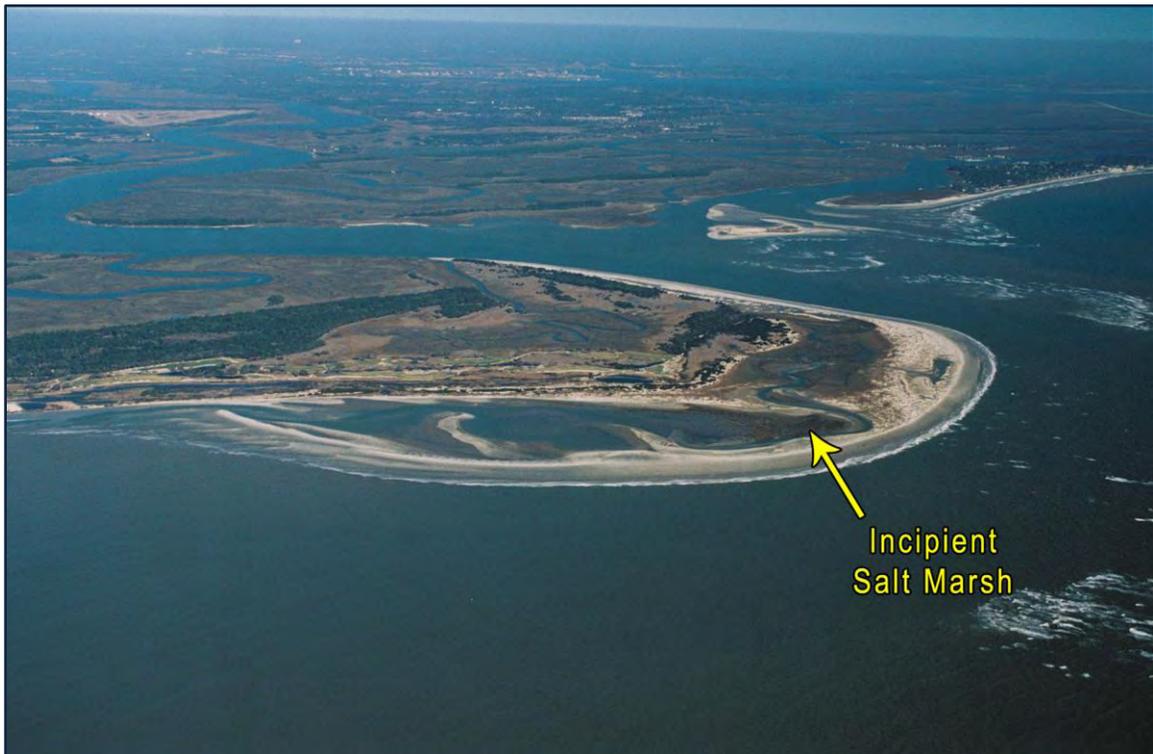
FIGURE 2.6. The eastern end of Kiawah Island in December 1998 (upper) and February 2005 (lower). Note the 1989 shoreline situated well inland from the outer beach. Shoals 1 and 2 added upward of 5 million cubic yards to Kiawah in the 1990s. As waves pushed the new sand shoreward, an incipient barrier island/lagoon/marsh formed. The new lagoon was flushed via a channel at the western end of the accreted beach. [From CSE 2007]

As longshore transport moved the shoal westward, the flushing channel migrated with the shoal, encroaching on the Ocean Course, specifically the 16th and 18th holes. The beach at the original Ocean Club clubhouse (near OCRM monument 2775) retreated over 500 ft between 2000 and 2005. The magnitude of the bypassing event was so great, it was apparent that severe erosion would continue for several years before the cycle would be complete (Gaudio & Kana 2001). The Ocean Course remained vulnerable to erosion as the shoal and flushing channel migrated westward. This led to the plan for beach restoration by CSE (2005).

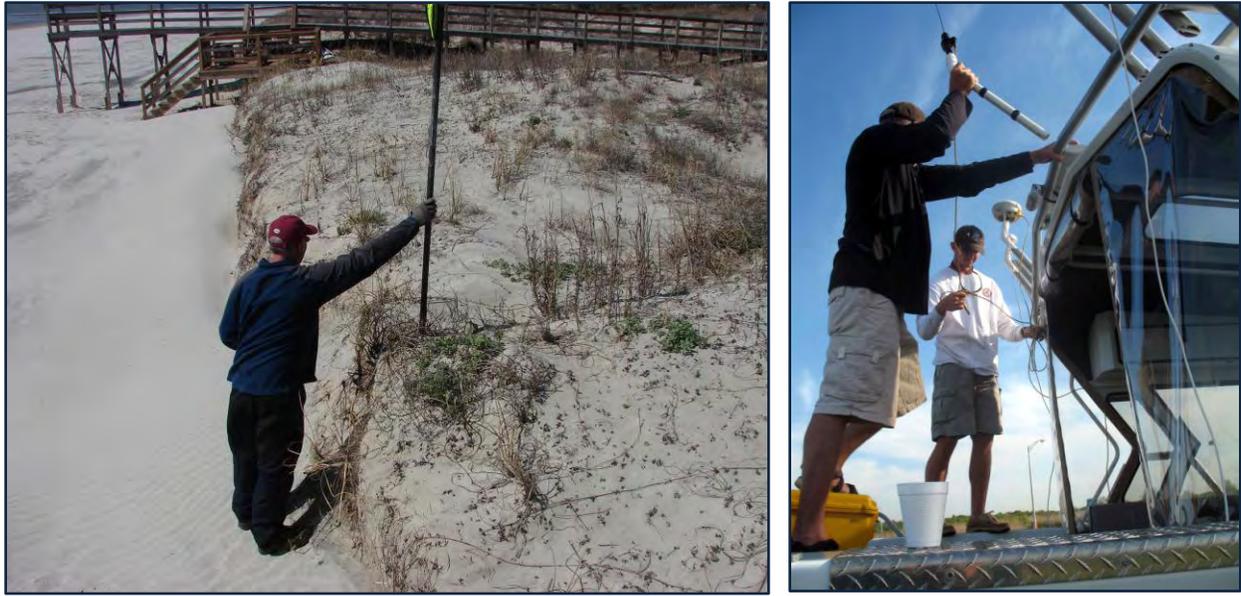
FIGURE 3.1.

CSE's survey methods involve land based data collection via RTK-GPS (upper Left) and hydrographic data collection via RTK-GPS linked to a precision echo-sounder. CSE's shallow-draft vessel the *R/V Congaree River* is shown in the lower image.

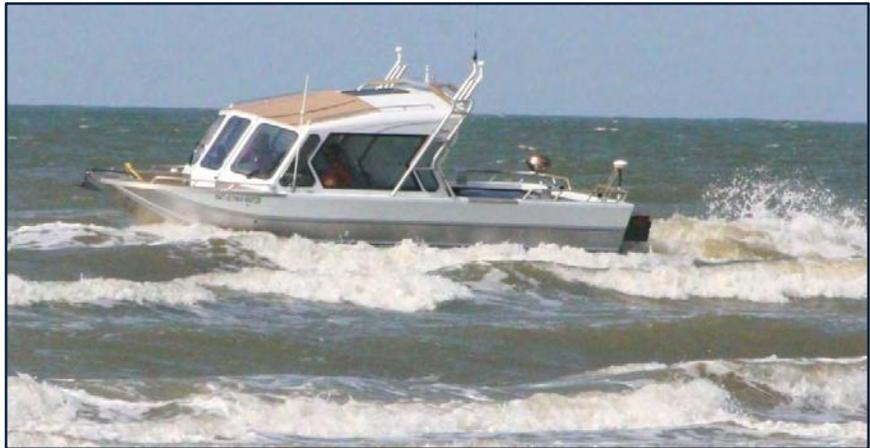
FIGURE 3.2.

CSE combines land-based and hydrographic data collection to produce continuous profiles of the beach. Land-based work is accomplished at low tide, while hydrographic work is performed at high tide. This allows for overlap of the two data collection methods and ensures quality data and a complete profile.

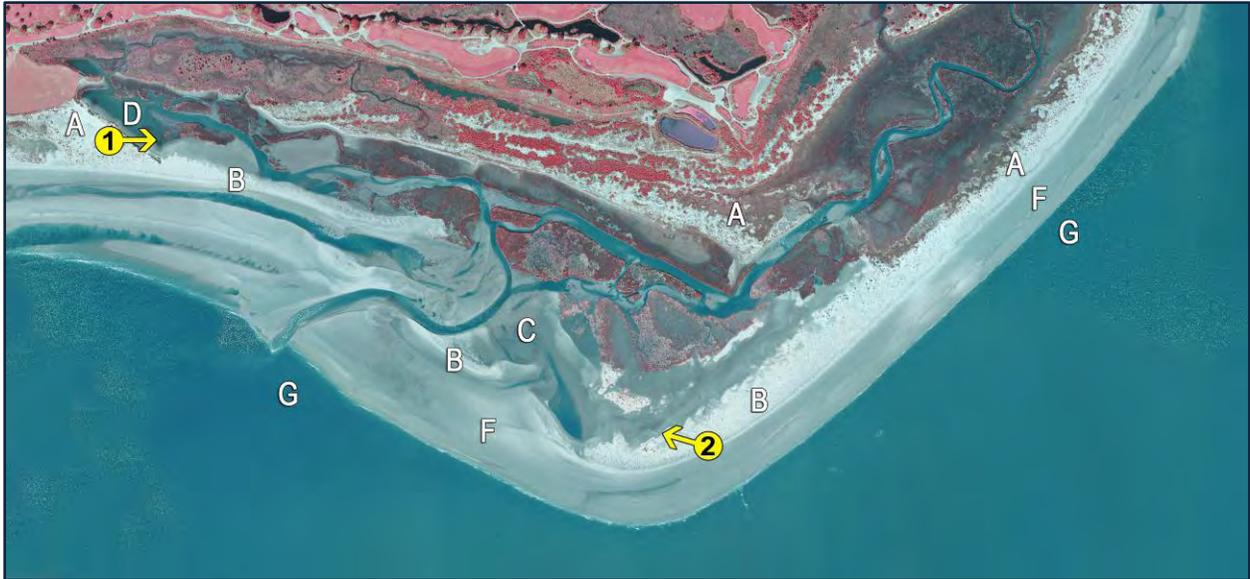
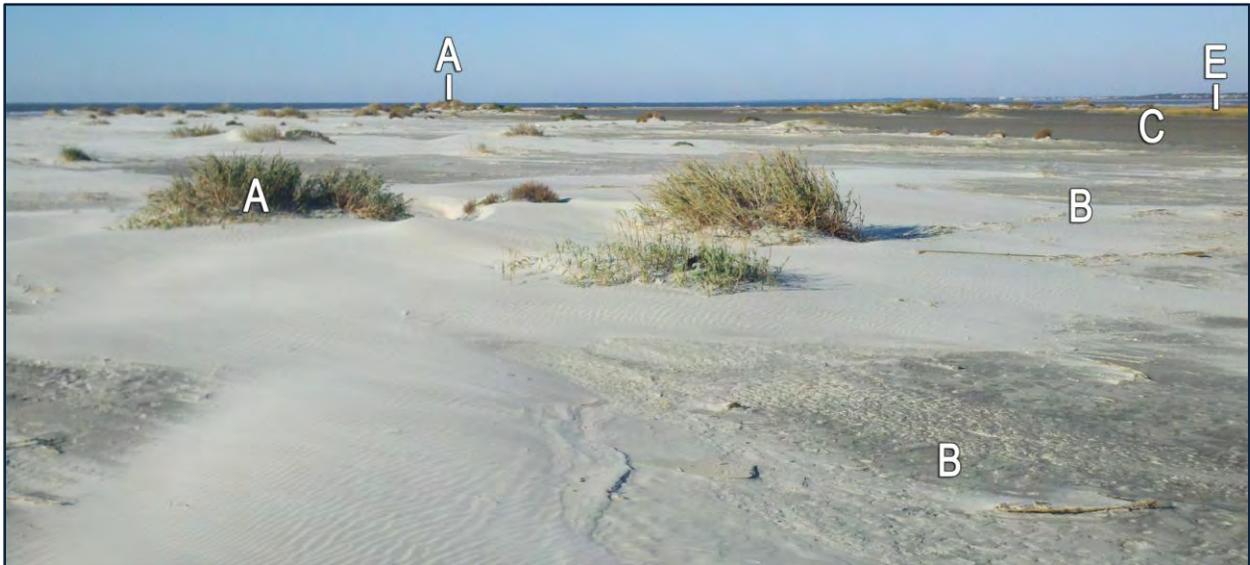
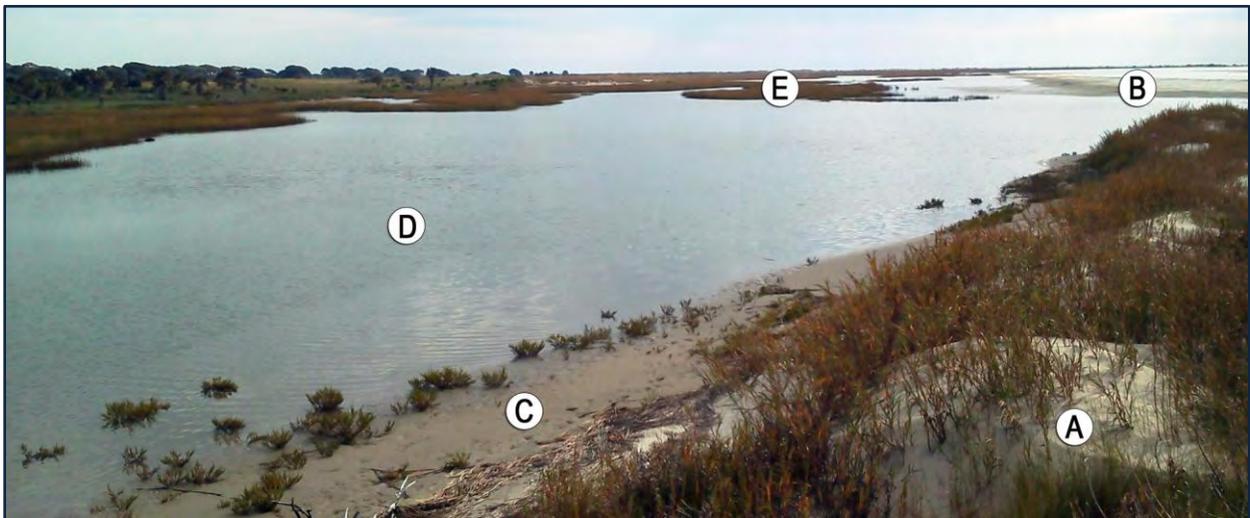
FIGURE 3.6. [following page] Habitat areas were delineated based on elevation and vegetation cover. The 2011 aerial image (upper) shows the distribution of habitats. The ground photos show typical habitats from the denoted areas in the upper photo (yellow labels): Location 1 (middle) and Location 2 (lower). Habitat areas are defined as follows:

(A) Stable dune	(B) Washover	(C) Sheltered intertidal	(D) Sheltered subtidal
(E) Vegetated marsh	(F) Exposed intertidal	(G) Exposed subtidal

A digital terrain model (DTM) was prepared in a similar manner as the pre-project and post-project models given in the final report. Habitat areas were delineated based on ground-truth data and experience from similar settings. The elevation ranges for identified habitats (Fig 3.6) are the NAVD-datum equivalent of the NGVD ranges reported in CSE (2007), specifically:

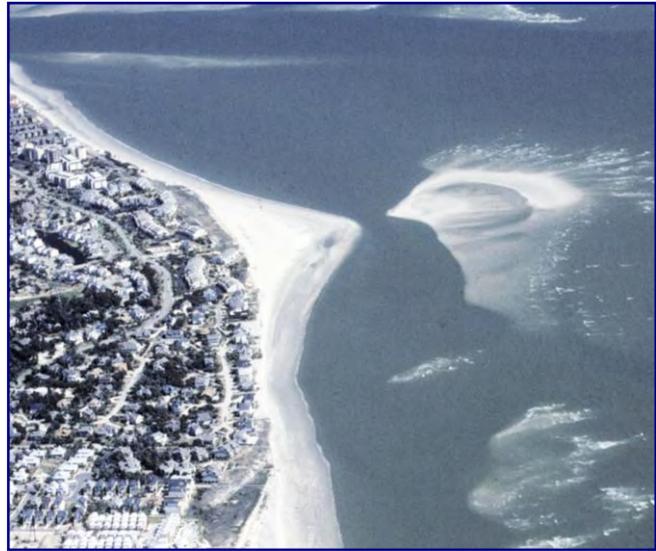
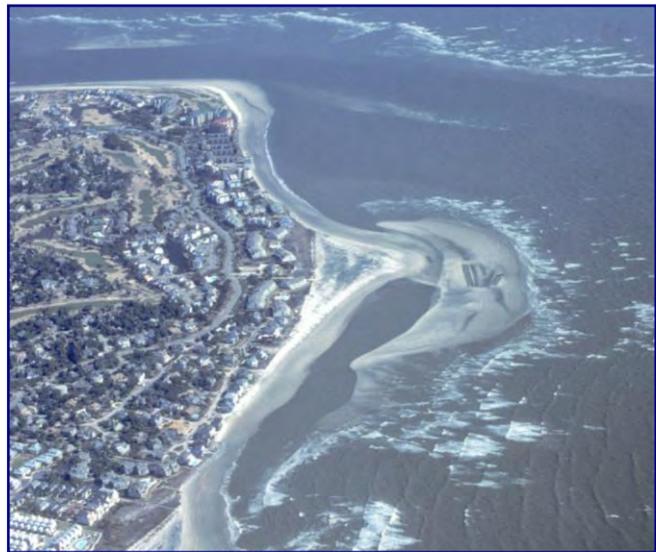
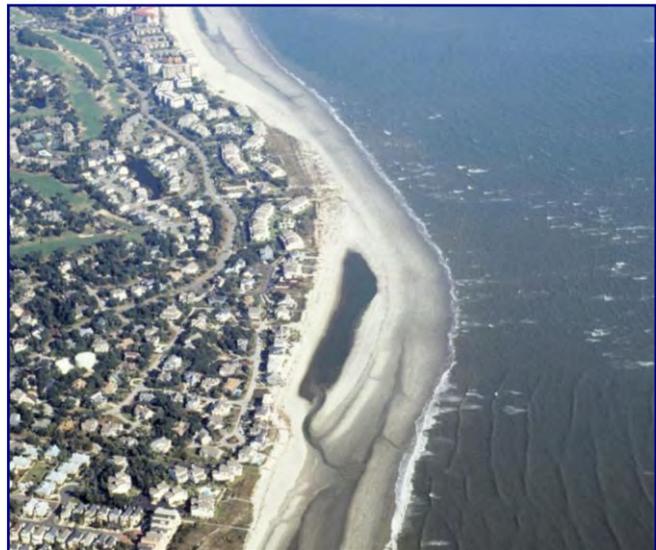
THE THREE STAGES OF SHOAL BYPASSING

Schematic of the shoal-bypass cycle originally modeled from a bypass event at Isle of Palms (SC). During Stages 1 and 2 of the cycle, accretion in the lee of the shoal is accompanied by erosion on either side of the attachment site. (After Kana et al 1985)

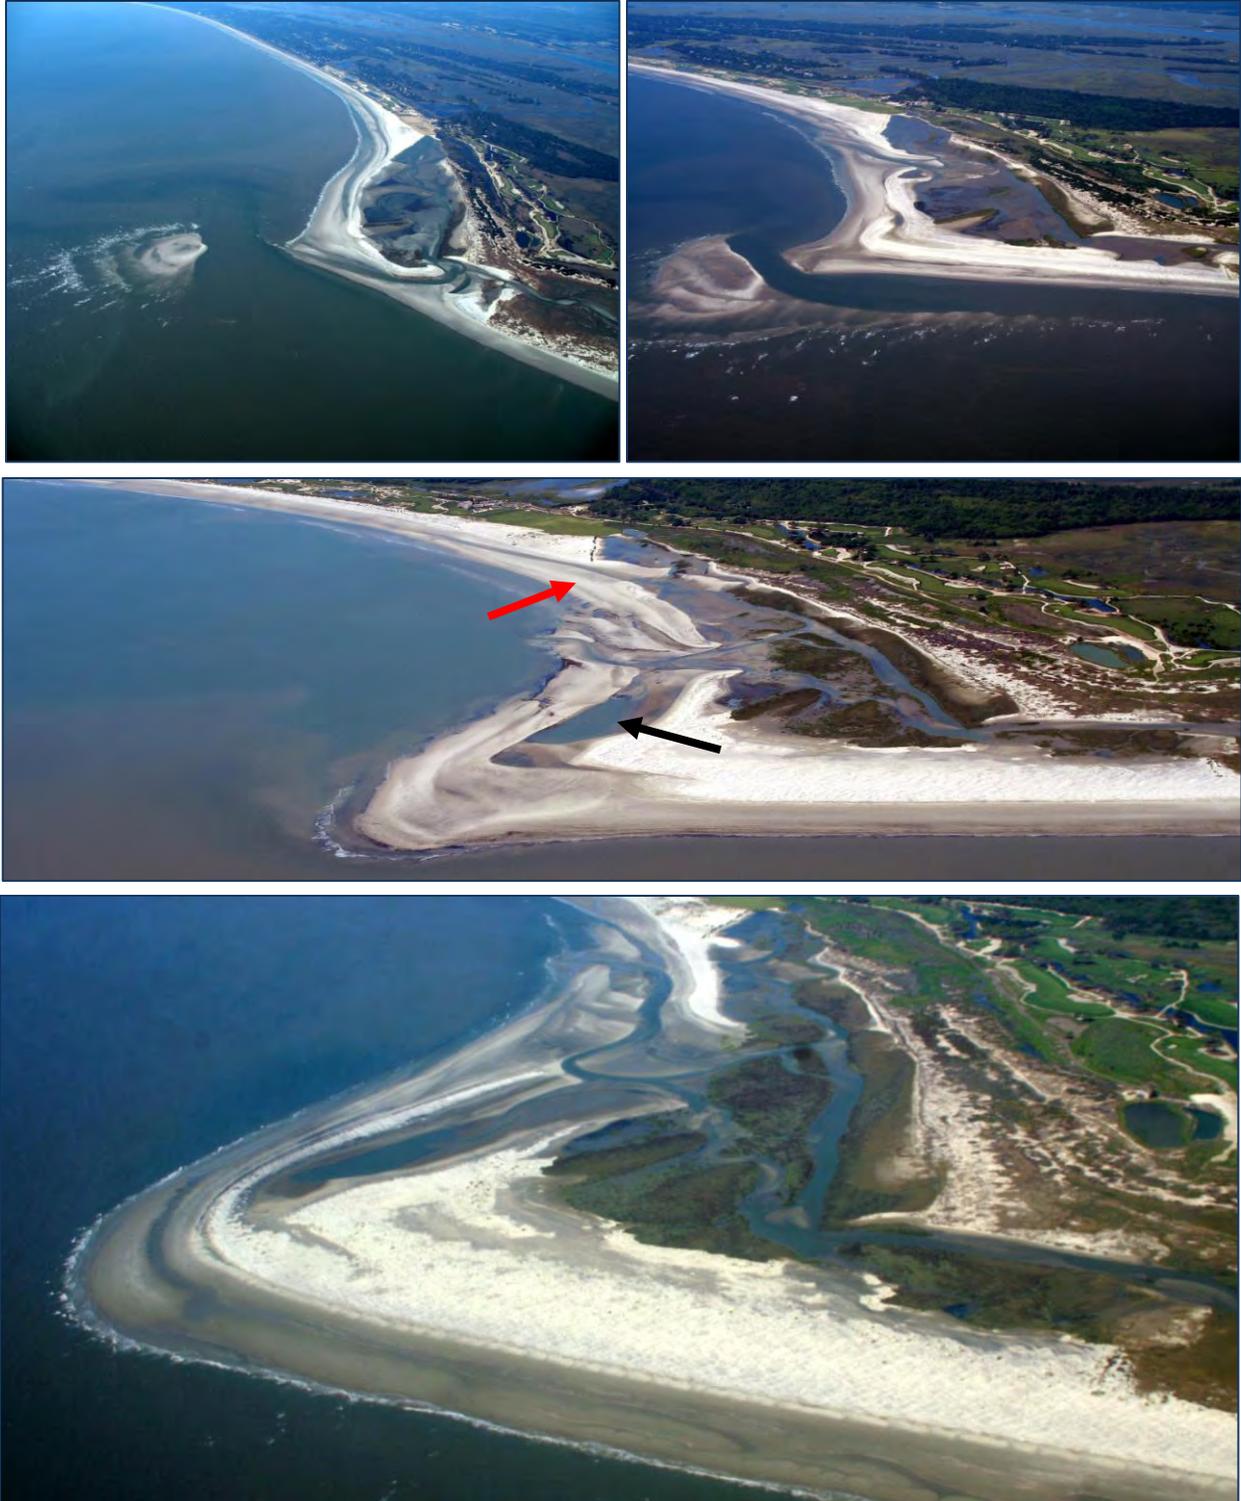
FIGURE 4.1. Oblique aerial photos of the west lagoon at the northeastern end of Kiawah Island. In December 2006 (upper left), an incipient shoal was present offshore of the eastern end of the lagoon. By May 2008 (upper right), the shoal was nearing attachment. A shoreline salient had formed on the outer barrier, as sand eroded from adjacent areas was deposited behind the shoal. The flushing channel had also relocated to the west and migrated westerly into the closure dike. The shoal had attached by April 2010 (middle), creating a small lagoon (black arrow) seaward of the original outer barrier. The flushing channel again relocated from the closure dike area (red arrow) to the central portion of the lagoon. Erosion of the shoal attachment site and downcoast spreading of sand rounded off the point of land from 2010 to April 2011 (bottom).

Rapid and large-scale volume changes led to closure of the original (constructed) flushing channel and opening of a new channel in the summer of 2007 (cf Fig 2.6). The new flushing channel was located near the center of the west lagoon, and migrated west between 2007 and 2009. It began to encroach on the constructed dike as it continued to migrate west. During this time (2007 to 2009), the outer barrier eroded via overtopping and sand spreading to the lee of the shoal, leaving it low, narrow, and susceptible to another breach. A new breach occurred between August 2009 and April 2010, and the old channel closed naturally. The new inlet was again located near the central portion of the west lagoon, near the attachment site of the western edge of the incipient shoal. The seaward end of the channel has meandered between 2010 and 2011; however, the channel throat has remained in the same general location (Fig 4.1).

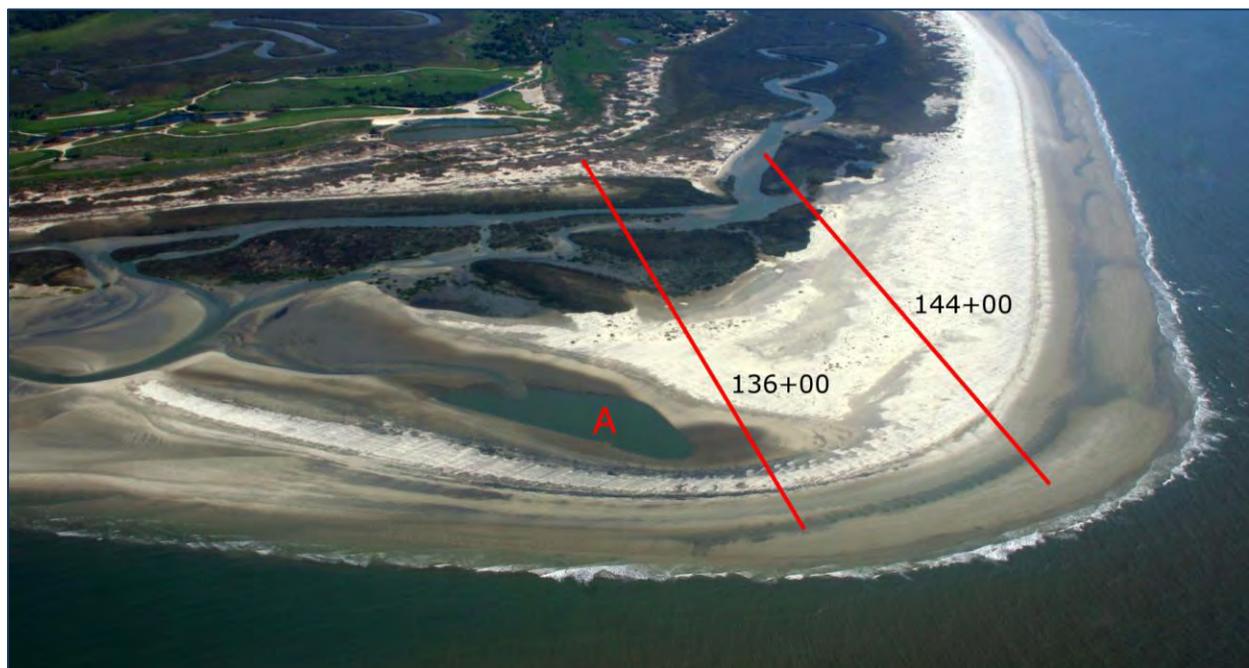
FIGURE 4.2. [UPPER] Profiles from station 144+00 showing attachment of a shoal between 2007 and 2010 and spreading (erosion) in 2011. The profile of the outer berm (dry beach) built seaward as the shoal approached, then the upper profile accreted as the shoal sand merged with the berm from 2009 to 2010. The profile eroded over 500 ft from 2010 to 2011 as shoal sand spread to adjacent areas [LOWER] The aerial photo from April 2011 shows the location of the profile. A small lagoon (A) which was formed during the latest shoal attachment remains as of April 2011.

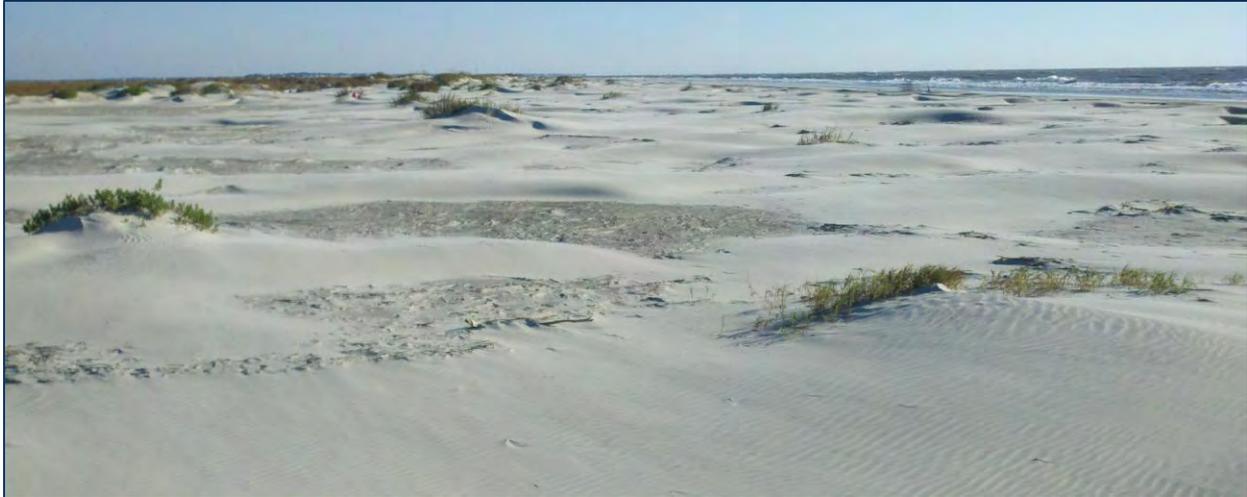
FIGURE 4.11. October 2011 ground photo looking northeast from station 148+00. Here washover habitat is transitioning into stable dune habitat. If the area continues to accrete, dune formation and expansion of vegetation should continue. If erosion occurs, this area will revert to washover habitat. Over the next few years, sand volume change will be impacted by the oncoming shoal bypass event.

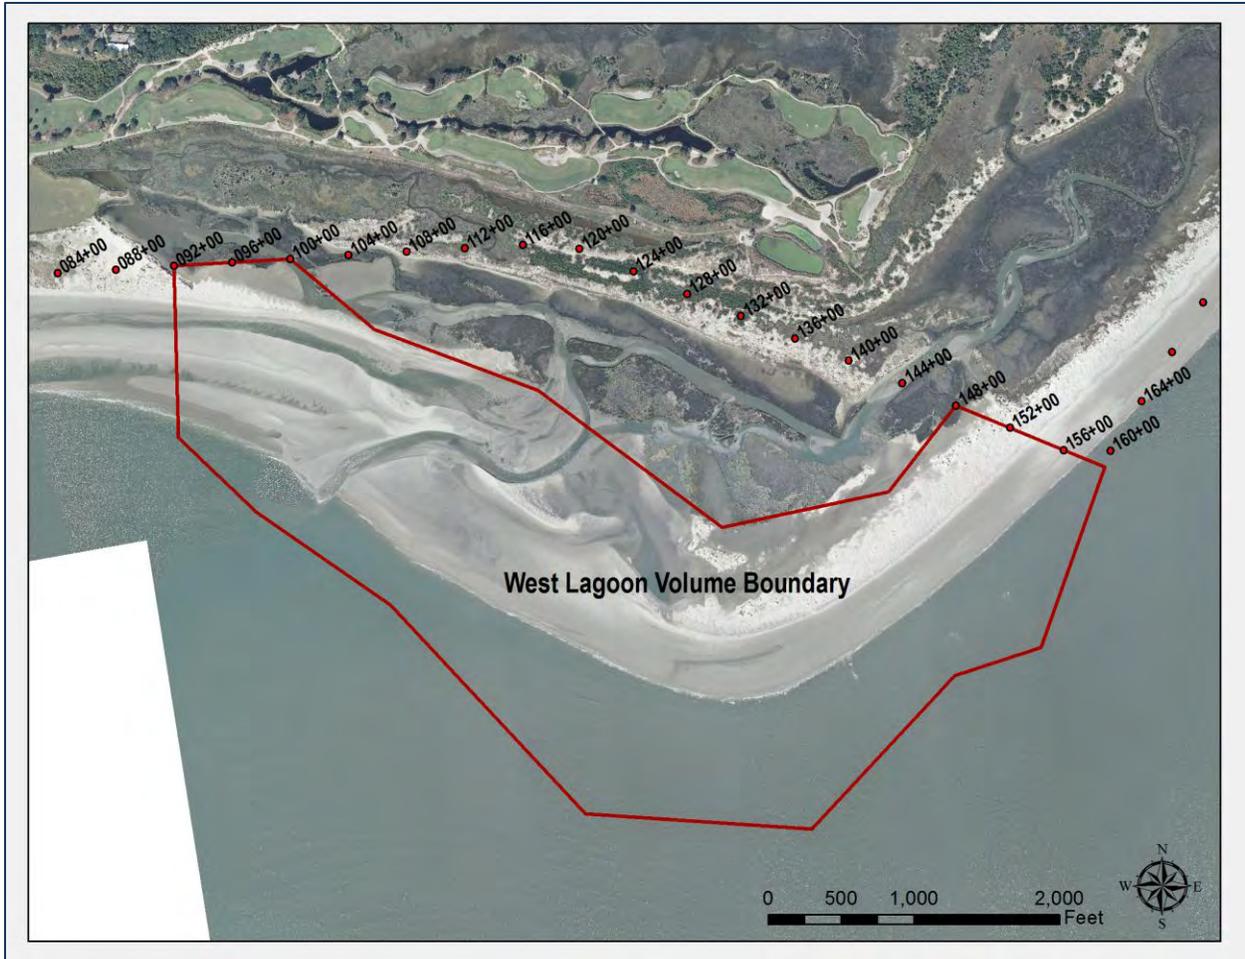
FIGURE 4.14. Boundary for the West Lagoon Reach used to compute beach volumes for the present report. Elevation models were produced for surveys between 2006 and 2011 and total beach volume within the boundary was calculated to -10 ft NAVD.

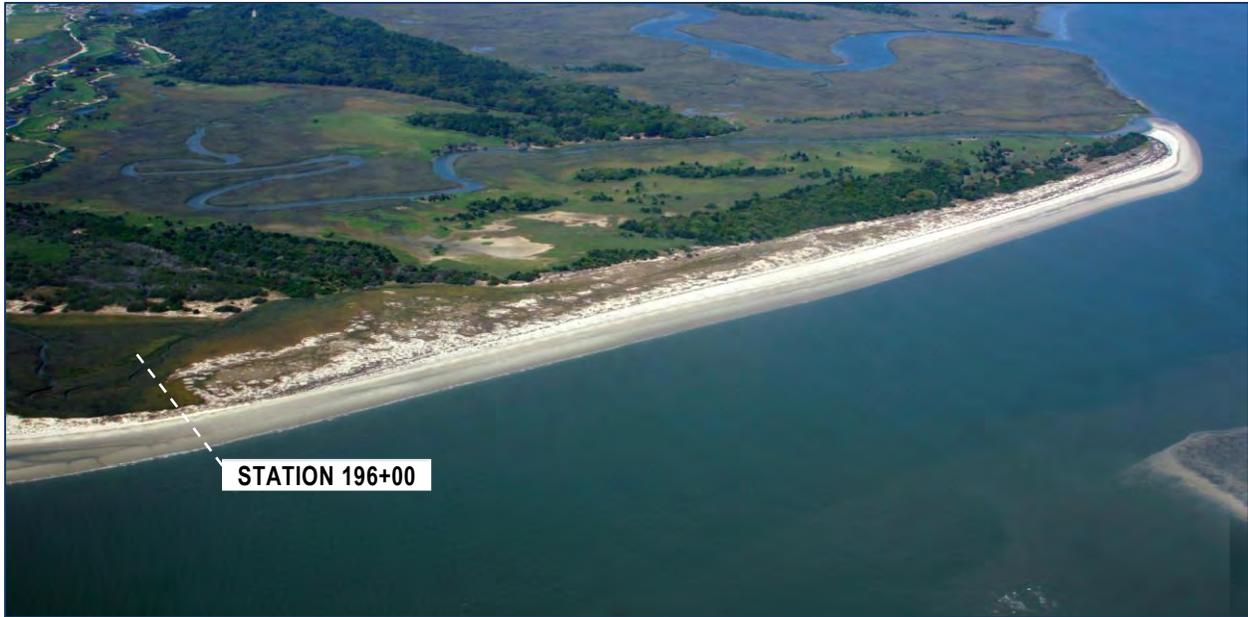
FIGURE 4.15. Oblique aerial photo of the Stono Inlet Reach taken April 2011. The 1989 shoreline was positioned at the most seaward tree-line visible in the image. Since then, shoal-bypass events have led to natural accretion along the northeastern end of the island.

The Stono Inlet Reach (Fig 4.15) spans ~6,000 ft from the eastern extreme of the island (station 192+00) to Penny’s Creek (station 252+00). This reach lost ~18,000 cy (3.0 cy/ft) of sand from October 2010 to October 2011. Since September 2006, this reach has generally been accreting, gaining an average of ~10,000 cy per year between 2006 and 2010. With the current erosion, the reach presently contains ~23,000 cy (3.8 cy/ft) more sand than the September 2006 condition. There were no discernible patterns of erosion within the reach. Individual stations ranged from 33.2 cy/ft accretion to 27.7 cy/ft erosion. Dunes are narrow between stations 192+00 and 208+00, and continued erosion of this area will eventually result in dune loss and overwash into the marsh. Near station 196+00, roughly 60 ft separate the marsh from the October 2011 escarpment (Fig 4.16).

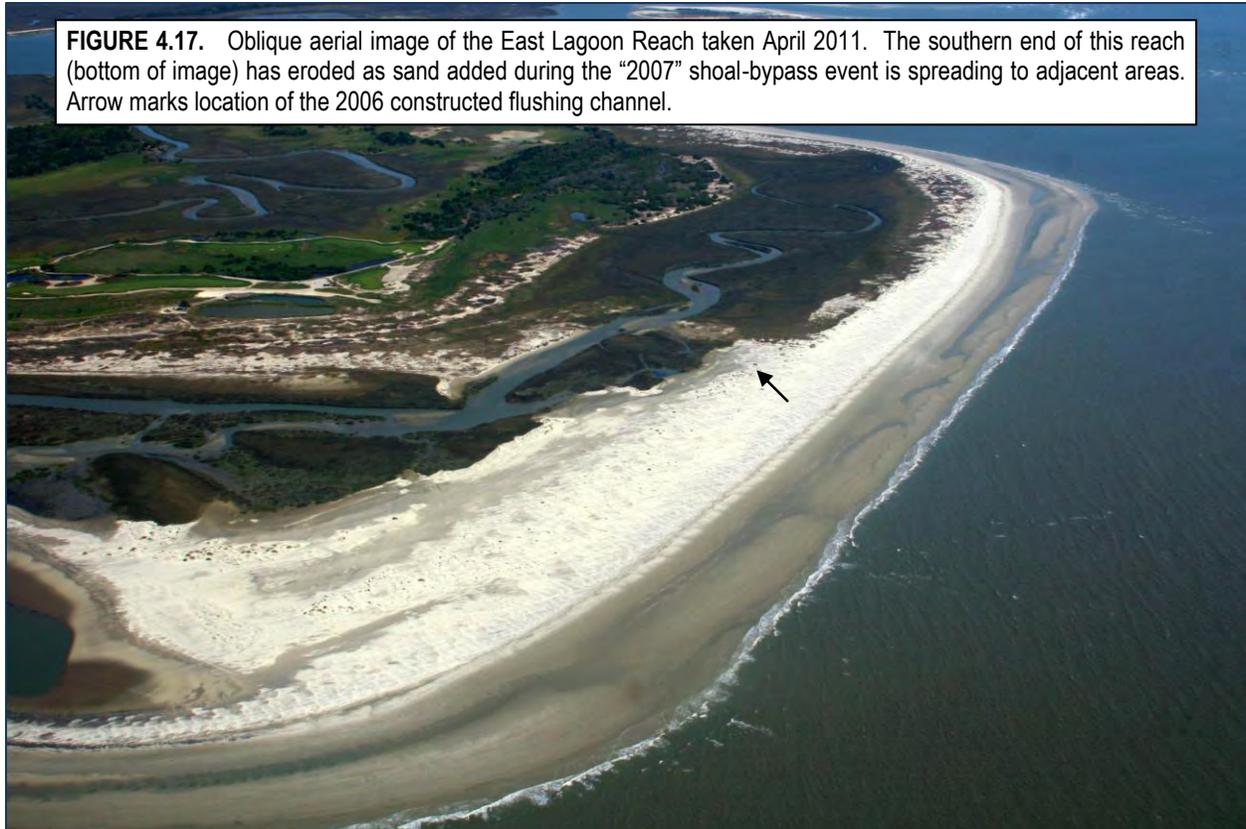
FIGURE 4.18. Panoramic image of the West Lagoon Reach, taken in October 2011. A narrow dune field separates the marsh filled lagoon from the ocean at the north end of the reach (Photos by S Traynum).

Despite erosion in the southern portion of the reach, dune growth is continuing and no stations show signs of berm overtopping (washover into the lagoon) during storm events. Extensive areas of sparsely vegetated and mostly flat berm are present at the southern end of the reach (Fig 4.18).

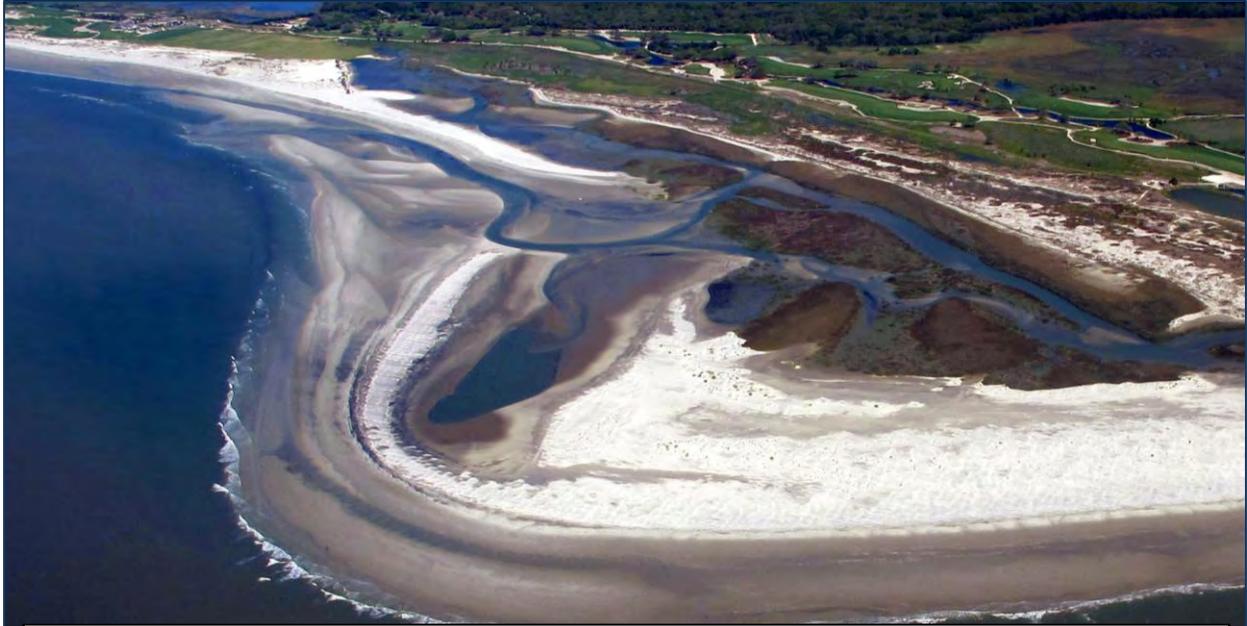
FIGURE 4.19a. Oblique aerial image of the West Lagoon Reach taken April 2011. The throat of the flushing channel has remained stable over the past year while the seaward end meandered across the active beach face.

The flushing channel of the lagoon remained in a similar position as in October 2010, with the main inlet throat near station 124+00. The seaward end of the channel meanders along the active beach, generally migrating west and periodically relocating via breaches through the berm to the east. Evidence of old meanders can be seen in aerial imagery (Fig 4.21).

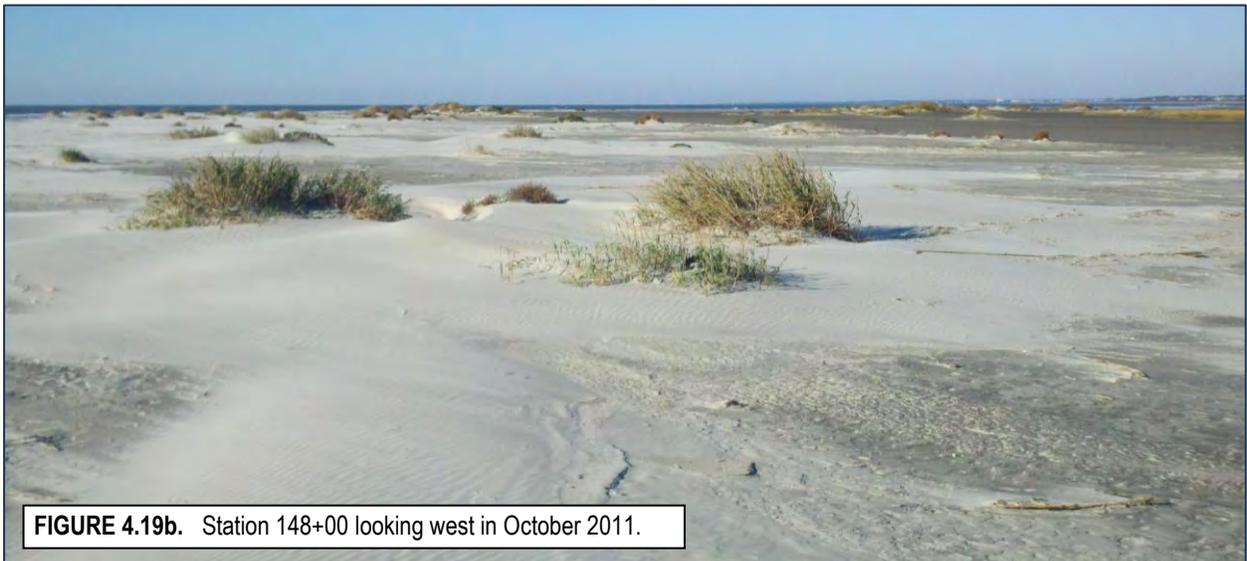
FIGURE 4.19b. Station 148+00 looking west in October 2011.

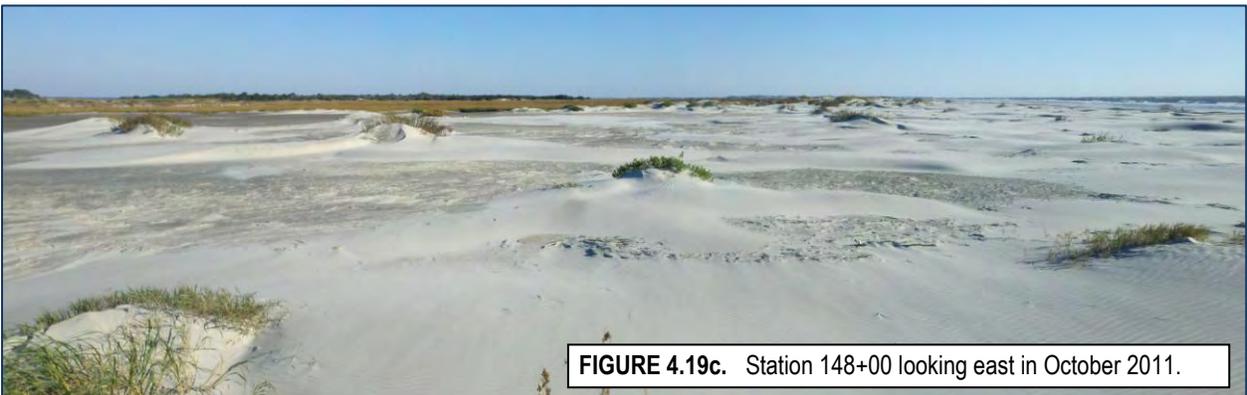
FIGURE 4.19c. Station 148+00 looking east in October 2011.

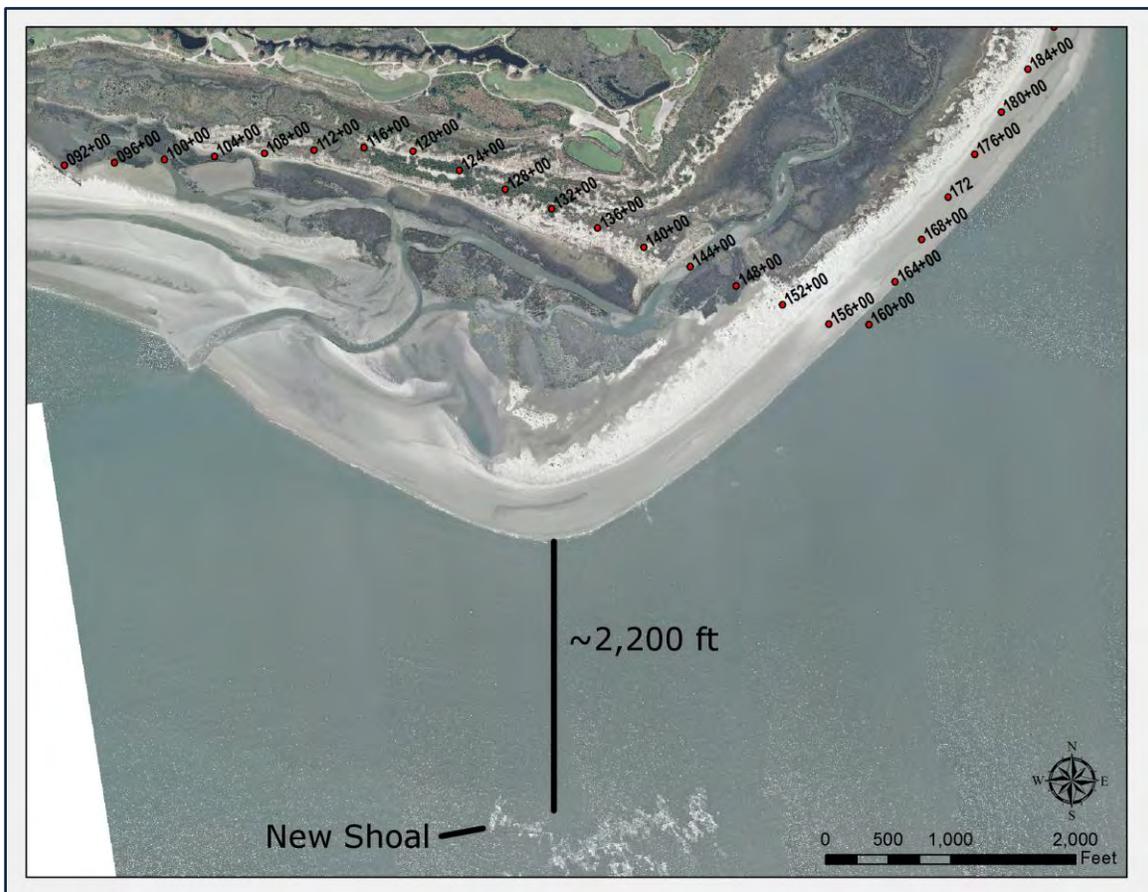
FIGURE 4.21. October 2011 aerial image of the eastern end of Kiawah Island showing an incipient shoal ~2,200 ft offshore of the southern foreland of the island. Over the next few years, this shoal will likely migrate onshore and attach to the beach.

Aerial imagery shows that a new shoal is emerging south of the project area roughly 2,200 ft offshore of the southern foreland of the island (Fig 4.21). This will likely be the next shoal that attaches to the beach. No estimate of the sand volume within the new shoal can be made with the available data; however, it appears to be of a similar scale as the “2007” shoal event. Since this is the first year that the shoal has been observed, the rate of migration is unknown. CSE expects this shoal to migrate landward over the next few years. Future surveys should monitor the shoal’s position, volume, and migration rate.

CSE recommends periodic surveys of the ebb-tidal delta of Stono Inlet to locate the position and determine the extent of offshore shoals over time, as these shoals are the source of sand for Kiawah Island and are responsible for the island's history of accretion.

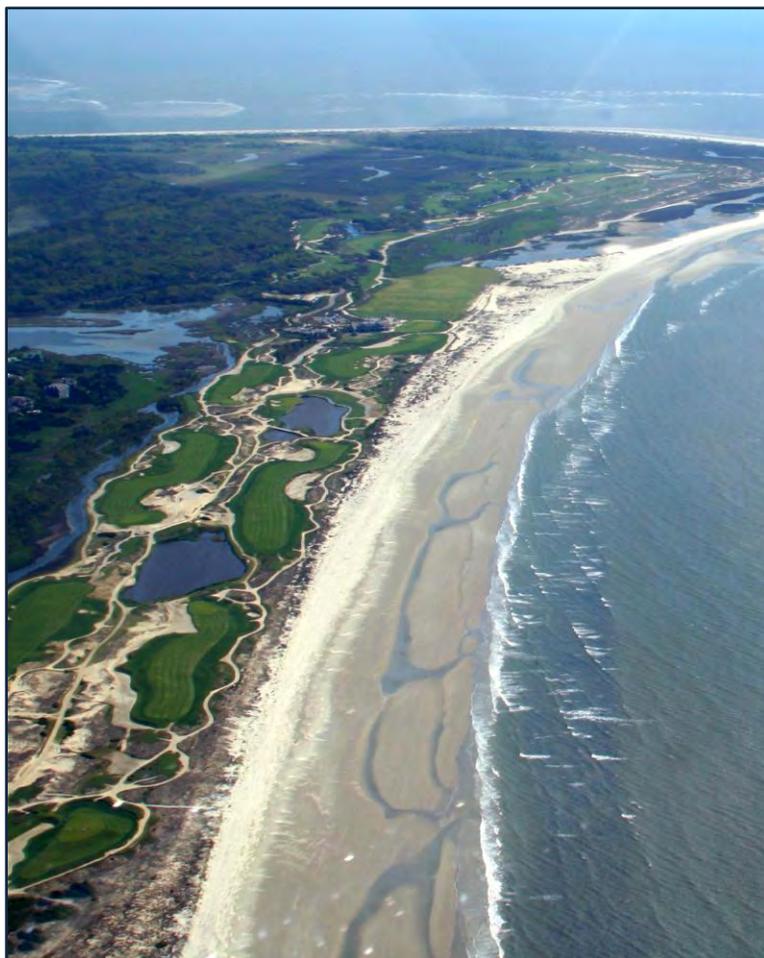
FIGURE 4.22. April 2011 oblique aerial image of the Ocean Course Reach.

The lagoon flushing channel is responsible for the change in shoreline position over the last few years. From 2007 to 2010, the channel migrated from the center of the lagoon to the west. This caused erosion of the eastern portion of the Ocean Course Reach as the channel encroached on the closure dike. In 2010, the channel naturally relocated to the east, eliminating the cause of erosion in the area of the old channel. Coupled with excess sand spreading from the “2007” shoal event, the site of the old channel has accreted while still supplying sand to downcoast areas of Kiawah Island.
