**2006 EAST END BEACH RESTORATION PROJECT
KIAWAH ISLAND SOUTH CAROLINA**

**Survey Report No 5
May 2012**

SURVEY REPORT NO 5
Annual Beach and Inshore Surveys

[CSE 2258YR5]
May 2012

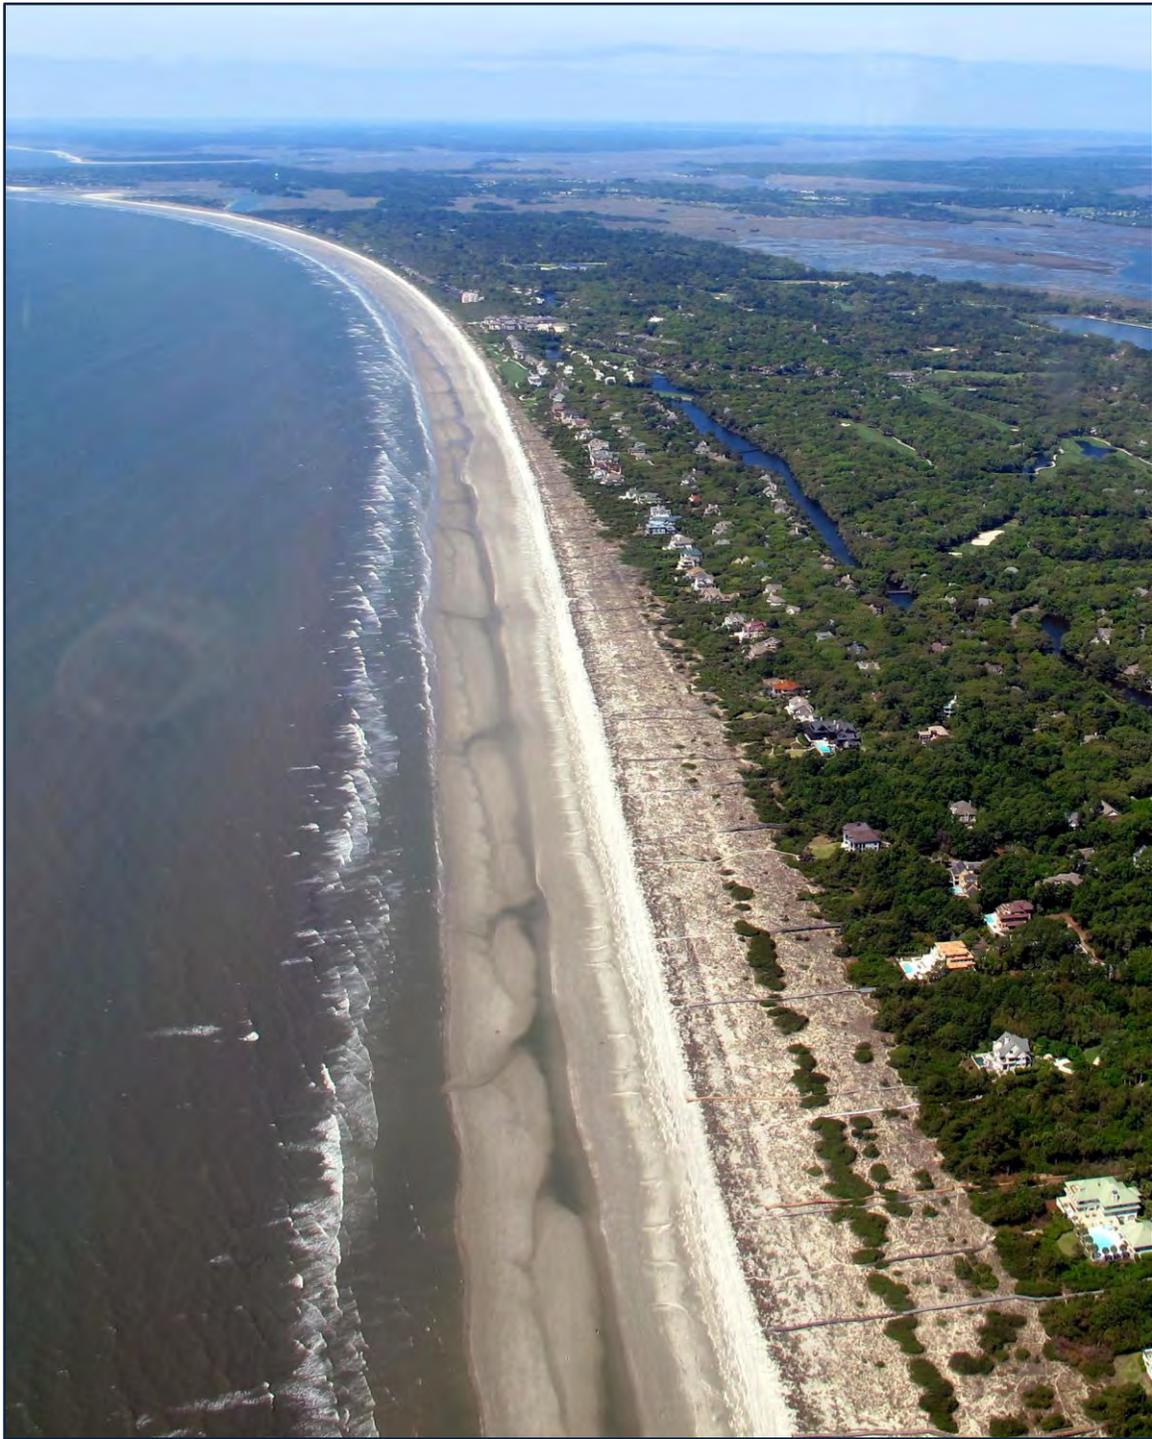
FIGURE 4.25. April 2011 aerial image of the Turtle Point Reach. A new line of shrub vegetation (typically waxed myrtle) can be seen propagating between sparsely vegetated foredunes in the lower third of the photo.

The Turtle Point Reach (Fig 4.25) extends 13,694 ft between OCRM 2684 (~100 ft east of the Sanctuary) to station 0+00 (west boundary of the 2006 project area). Between 2010 and 2011, the length of beach between stations 2705 and 2730 lost a total of 37,200 cy while the beach between stations 2685 and 2705 gained 33,300 cy. The total volume loss for the reach was ~3,900 cy or only 0.3 cy/ft. The Turtle Point Reach shows a gain of 3.3 cy/ft compared to the 2007 condition and a gain of 38.2 cy/ft compared to the 1999 condition. All profiles in the Turtle Point Reach show dune growth and seaward expansion of the berm since 1999.

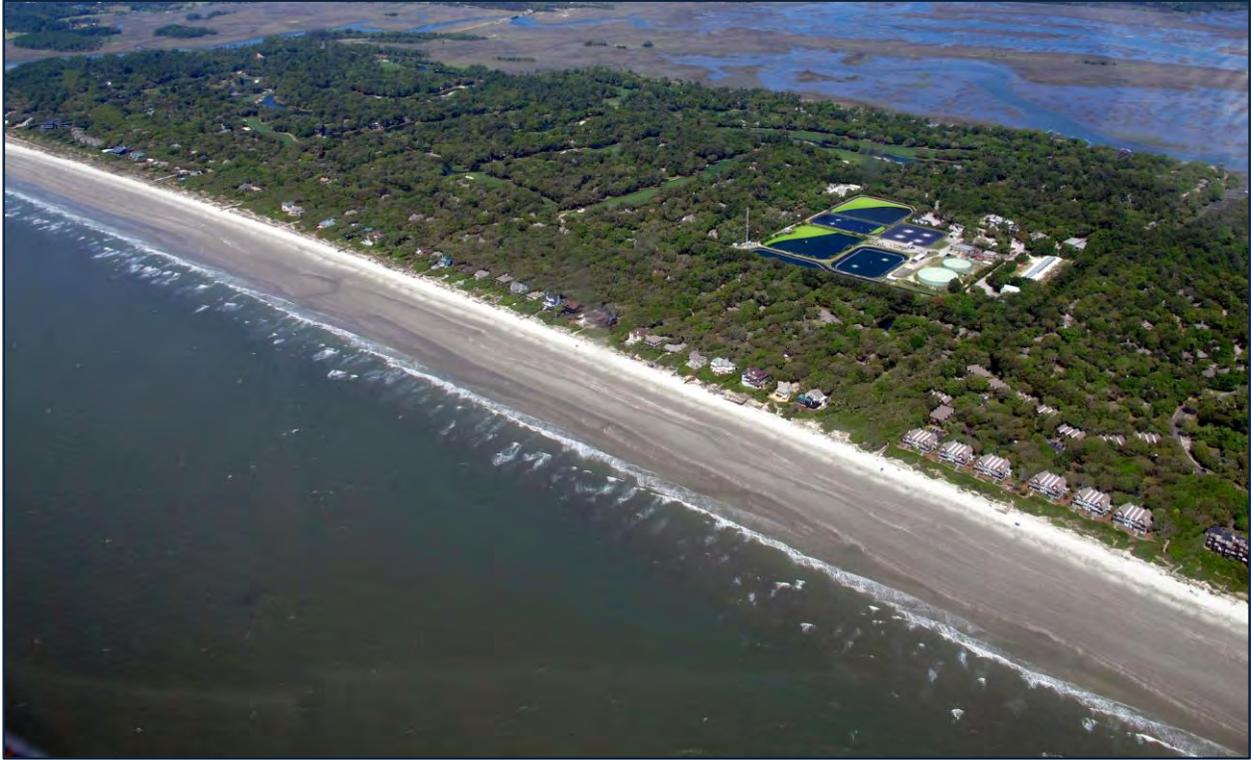
FIGURE 4.26. April 2011 aerial image of the West Beach Reach.

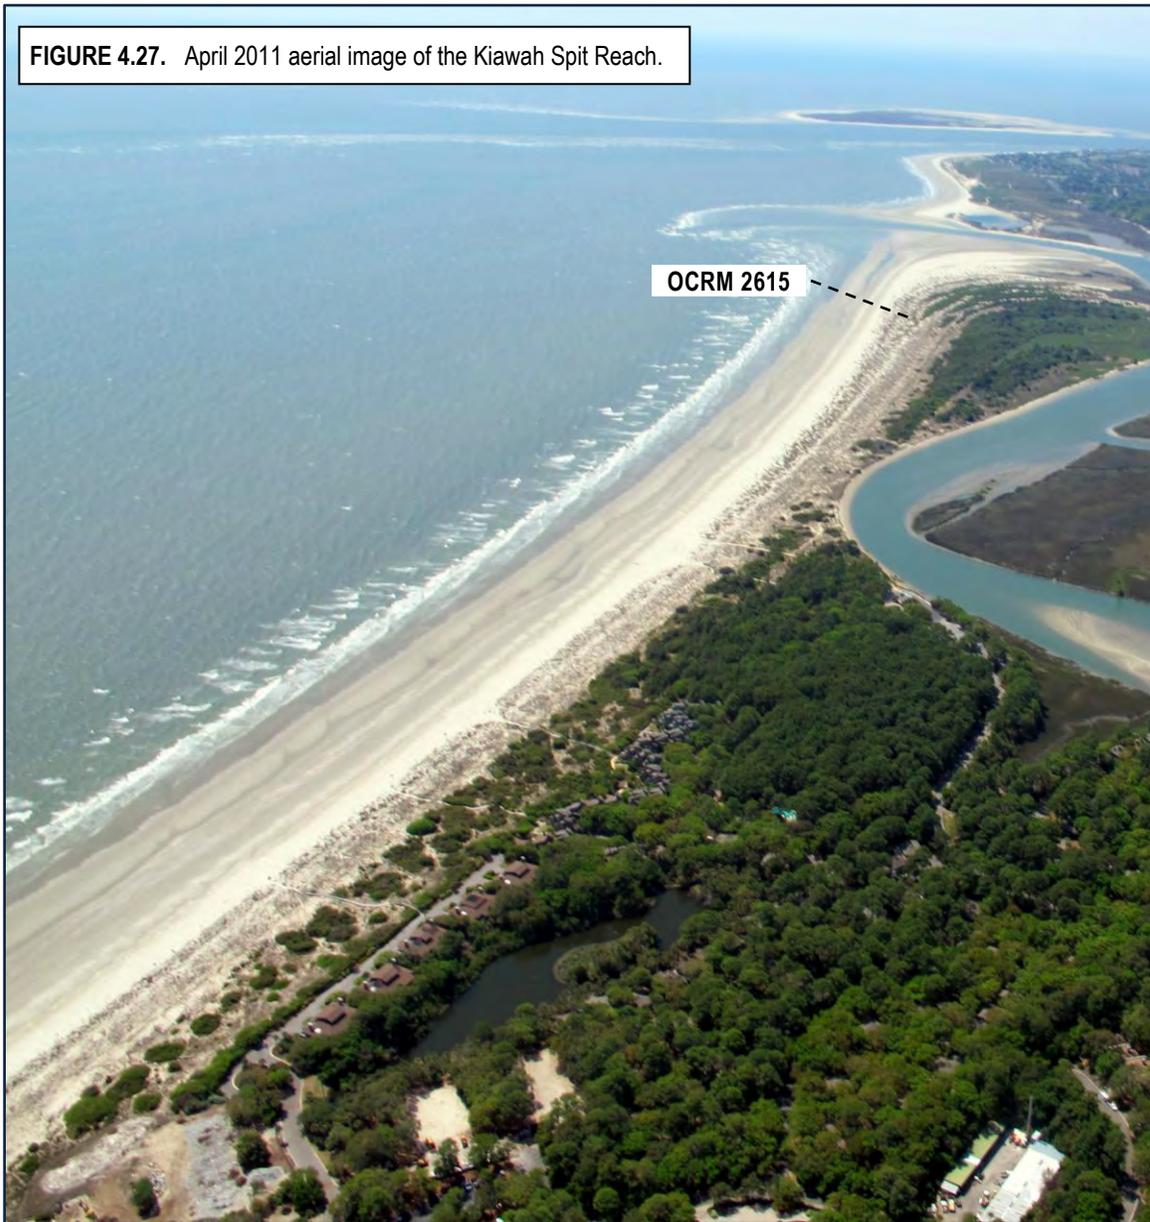
The Kiawah Spit Reach (Fig 4.27) encompasses the downcoast end of the island. It acts as a collection site for sand transported by longshore currents from upcoast areas. As wave action transports sand to the west, it feeds the spit, causing growth into Captain Sams Inlet and forcing the inlet to migrate toward Seabrook Island. This 5,658-ft reach lost ~27,100 cy (4.8 cy/ft) of sand between October 2010 and October 2011 (to -10 ft NAVD), which is abnormal for this area. Erosion was most severe at station 2615, which lost 14.6 cy/ft. The volume calculation does not include the portion of the beach west of station 2615 to Captain Sams Inlet. This downcoast area has accumulated sand as the inlet migrates toward Seabrook Island. The Kiawah Spit Reach has gained ~95,000 cy since 2007 and ~546,000 cy (7.7 cy/ft per year) since 1999.
