**2006 EAST END BEACH RESTORATION PROJECT
KIAWAH ISLAND SOUTH CAROLINA**

**Survey Report No 8
September 2015**

SURVEY REPORT NO 8
Annual Beach and Inshore Surveys

[CSE 2392 YR8]
September 2015

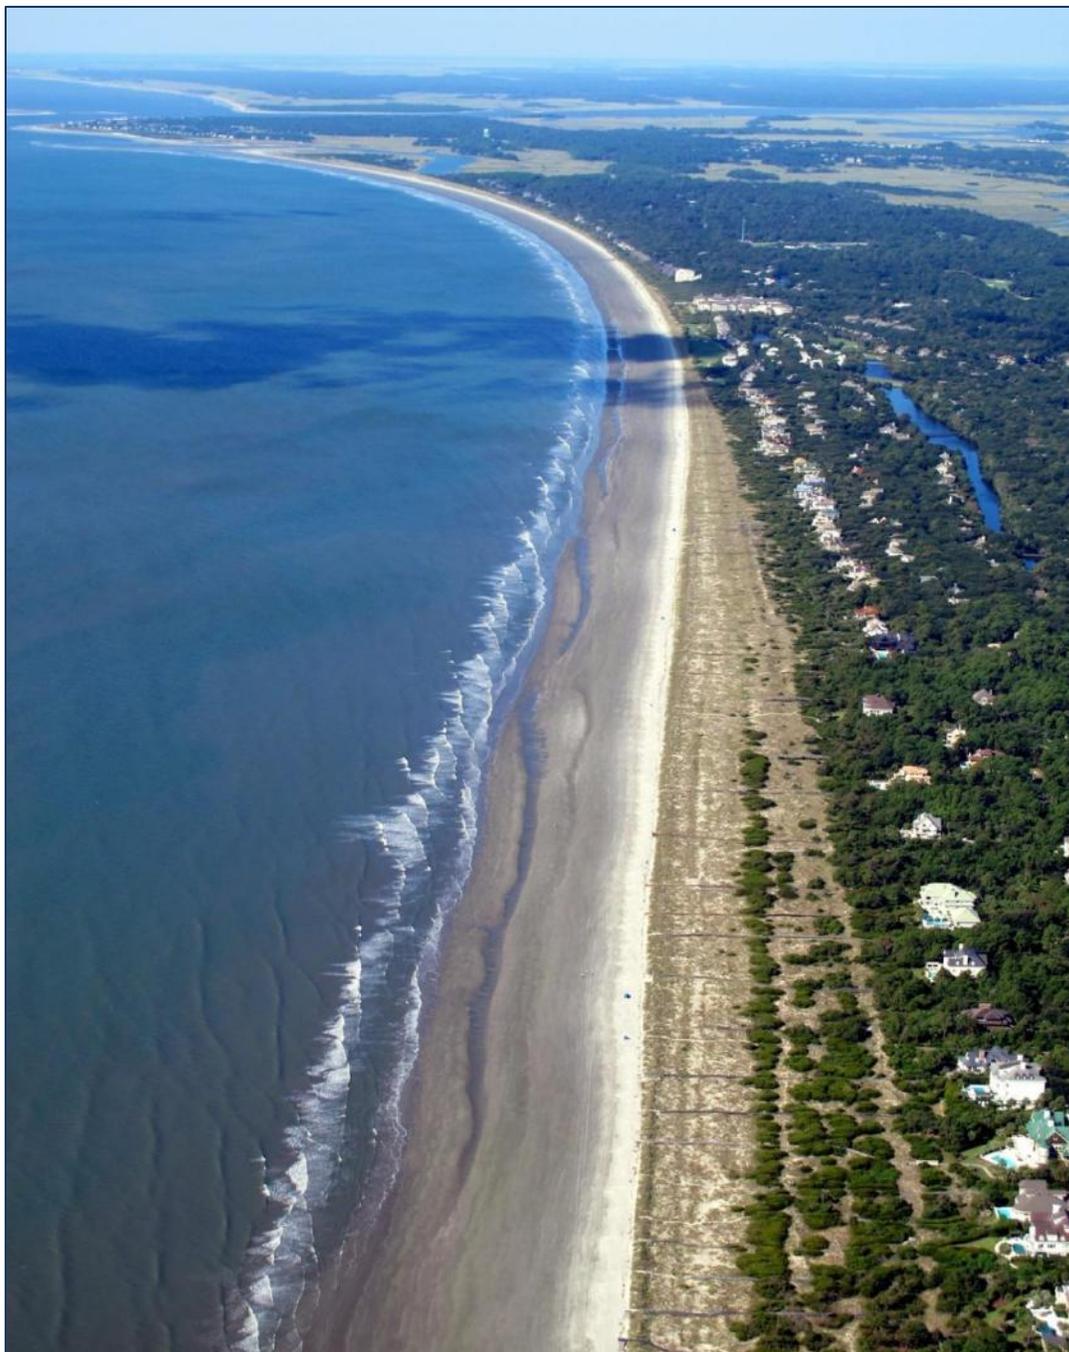
FIGURE A. Kiawah Island remains one of the healthiest beaches in South Carolina (September 2012 aerial).

Kiawah Island remains one of the healthiest beaches in South Carolina (Fig A). The results of shoreline monitoring and tracking the sand supply have provided new insight into the formation of barrier islands and rates of evolution of important habitats. Based on the results herein, the prognosis for the future is favorable for Kiawah's beach.

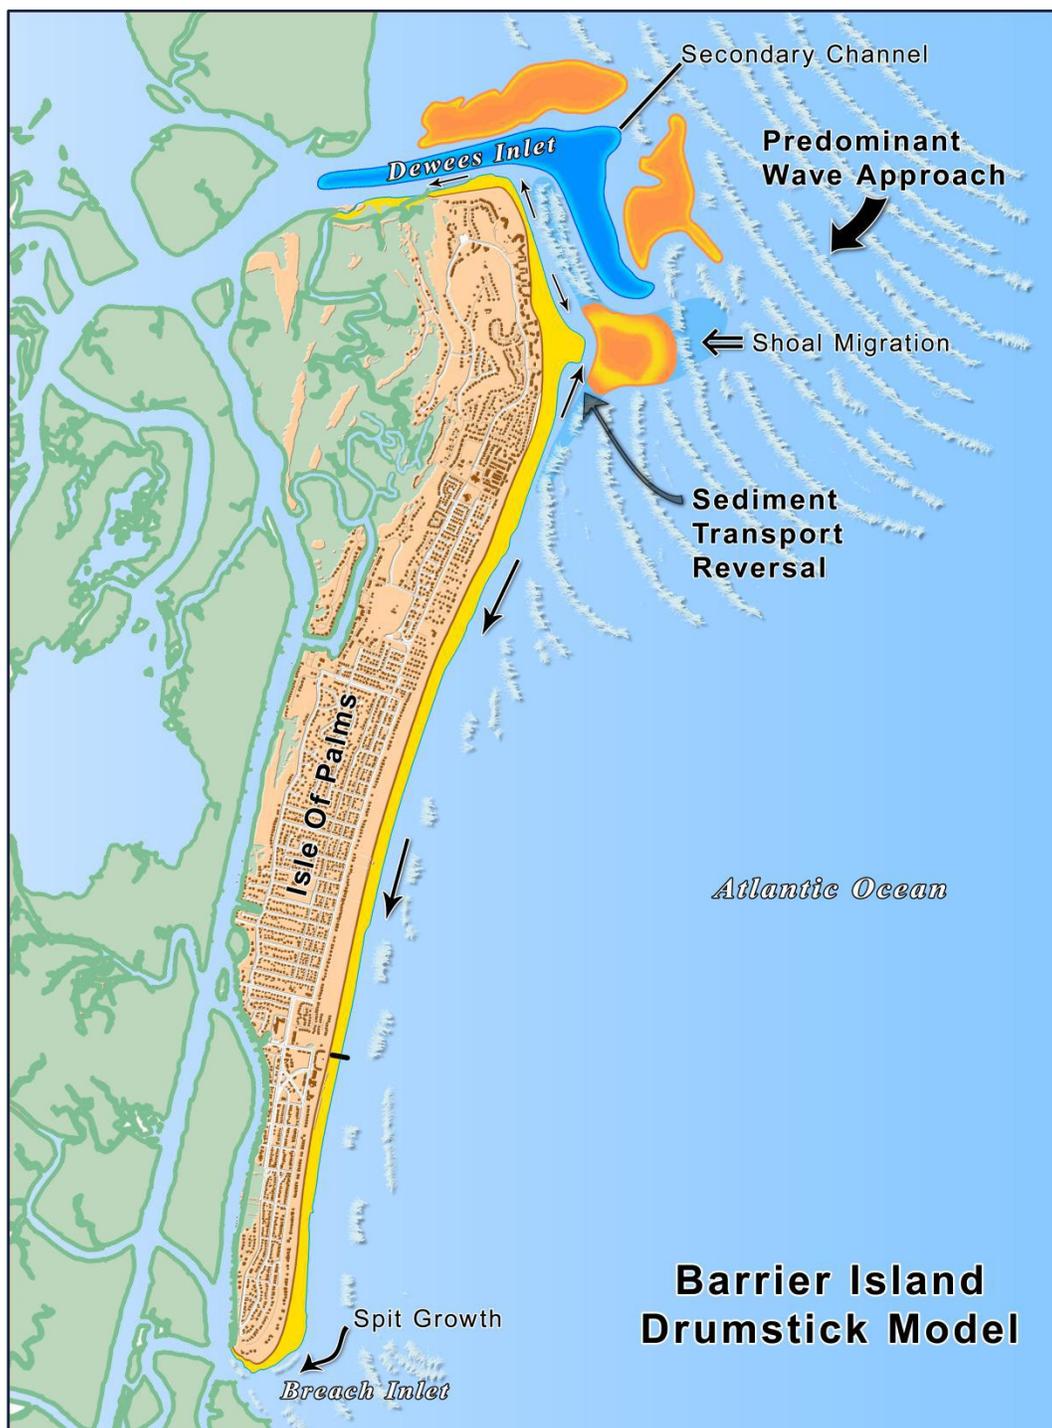
FIGURE 2.2. Barrier island drumstick model (after Hayes 1977) using Isle of Palms as an example. The upcoast end is wider due to additions of sand from shoal-bypass events in the inlet. Net transport to the south builds a spit at the downcoast end of the island.

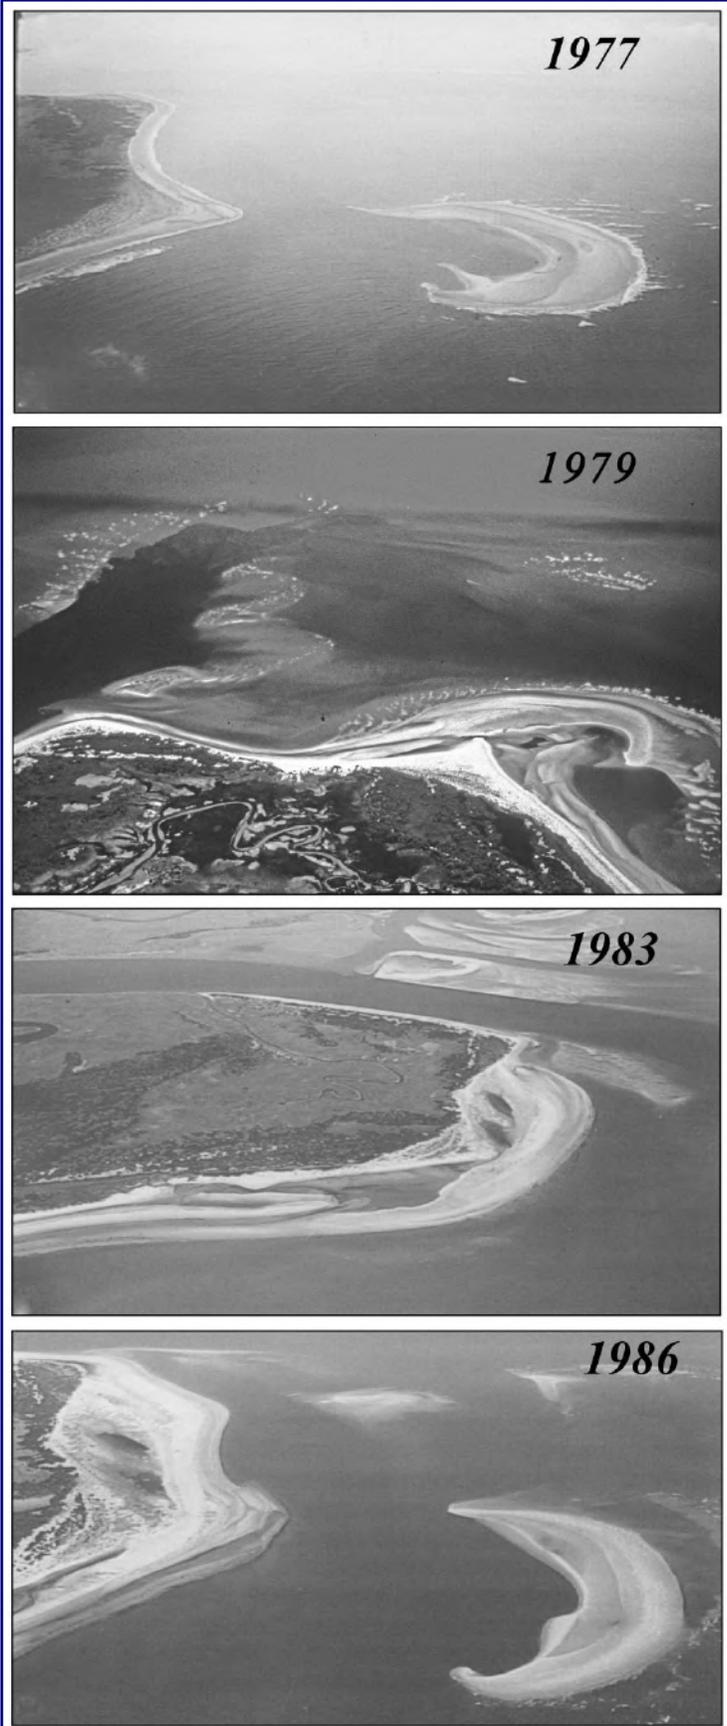
FIGURE 2.6

Schematic of the shoal-bypass cycle originally modeled from a bypass event at Isle of Palms (SC). During Stages 1 and 2 of the cycle, accretion in the lee of the shoal is accompanied by erosion on either side of the attachment site. (After Kana et al 1985)

Shoal bypassing at the east end of Kiawah Island.

Stage 1 in 1977 (upper). Stage 2 in January 1979 (upper middle) (courtesy of Research Planning Institute Inc). Stage 3 in 1983 (lower middle). Stage 1 in 1986 (lower). Note the similarity between the 1977 shoal and the 1986 shoal, but the additional sand accumulated on Kiawah in 1986. [After Kana et al 1999]

Once attached, the shoal is considered to be in Stage 3 of the shoal-bypass cycle (Kana et al 1985, Williams & Kana 1986). Waves continue to push the shoal landward and upward while spreading sand laterally along the beach. Shoal spreading (Stage 3) provides natural nourishment with sand moving downcoast via longshore currents.

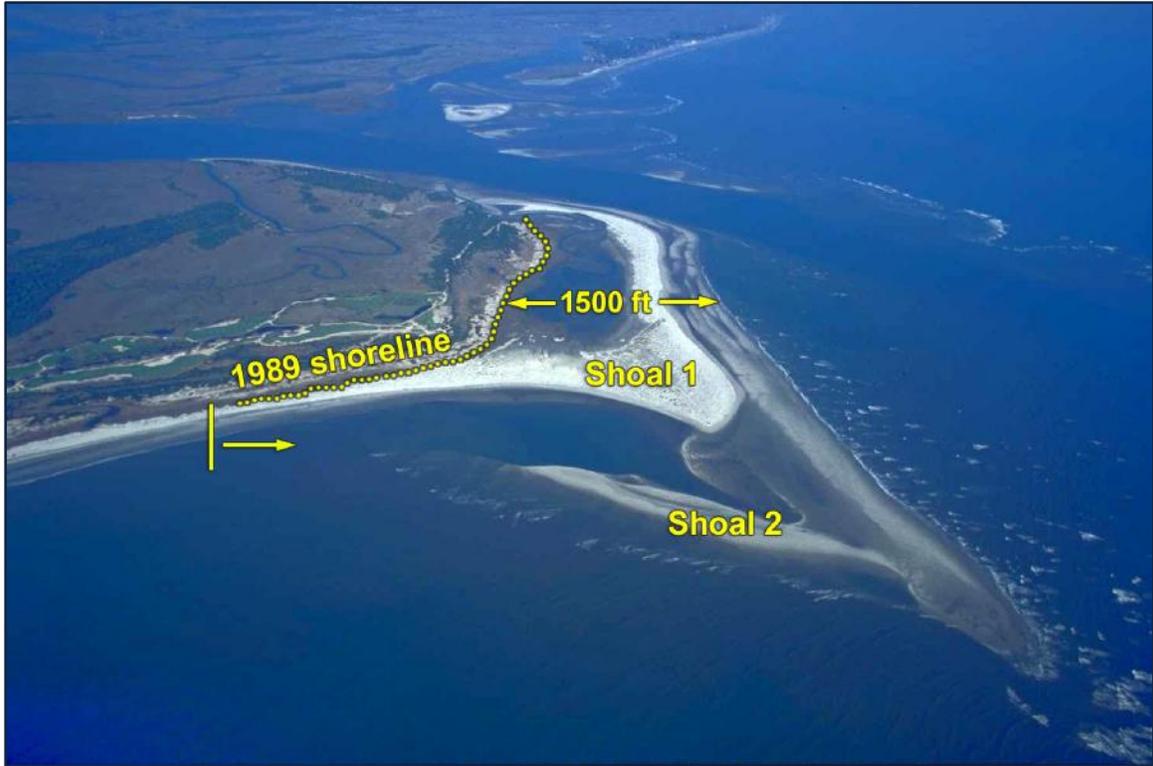
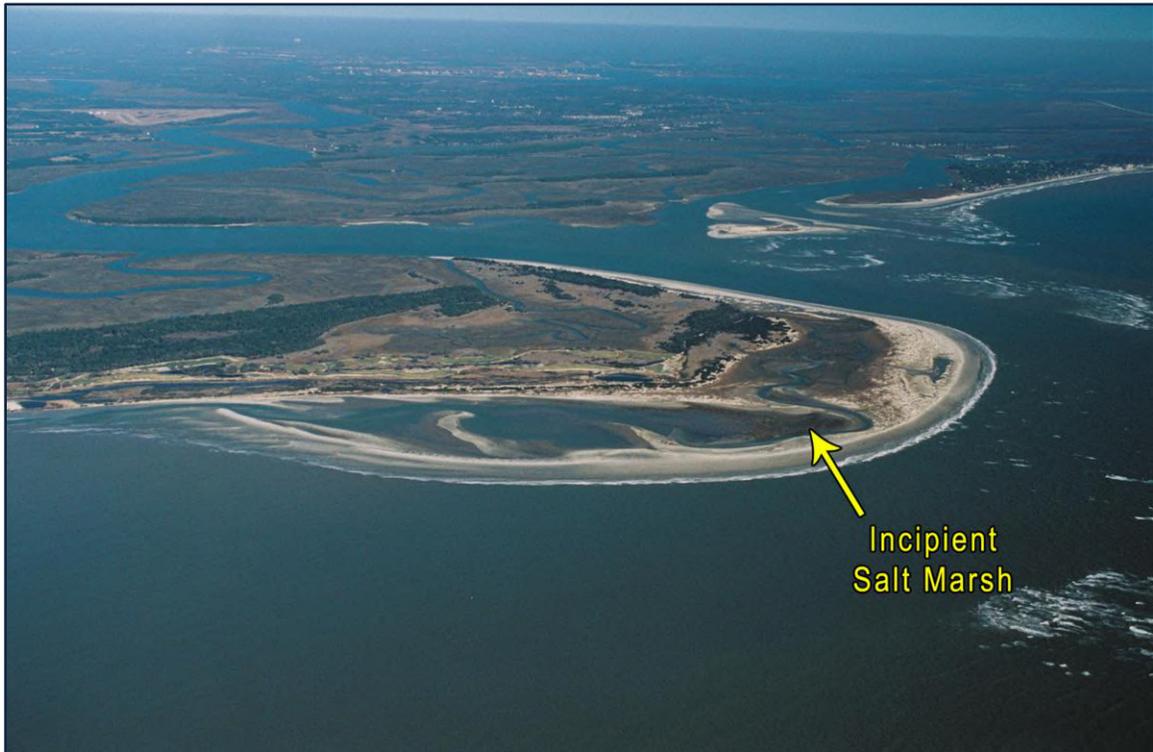
FIGURE 2.7. The eastern end of Kiawah Island in December 1998 (upper) and February 2005 (lower). Note the 1989 shoreline situated well inland from the outer beach. Shoals 1 and 2 added upward of 5 million cubic yards to Kiawah in the 1990s. As waves pushed the new sand shoreward, an incipient barrier island/lagoon/marsh formed. The new lagoon was flushed via a channel at the western end of the accreted beach. [From CSE 2007]

As longshore transport moved the shoal westward, the flushing channel migrated with the shoal, encroaching on the Ocean Course, specifically the 16th and 18th holes. The beach at the original Ocean Course Clubhouse (near OCRM monument 2775) retreated over 500 ft between 2000 and 2005. The magnitude of the bypassing event was so great, it was apparent that severe erosion would continue for several years before the cycle would be complete (Gaudiano & Kana 2001). The Ocean Course remained vulnerable to erosion as the shoal and flushing channel migrated westward. This led to the plan for beach restoration by CSE (2005).

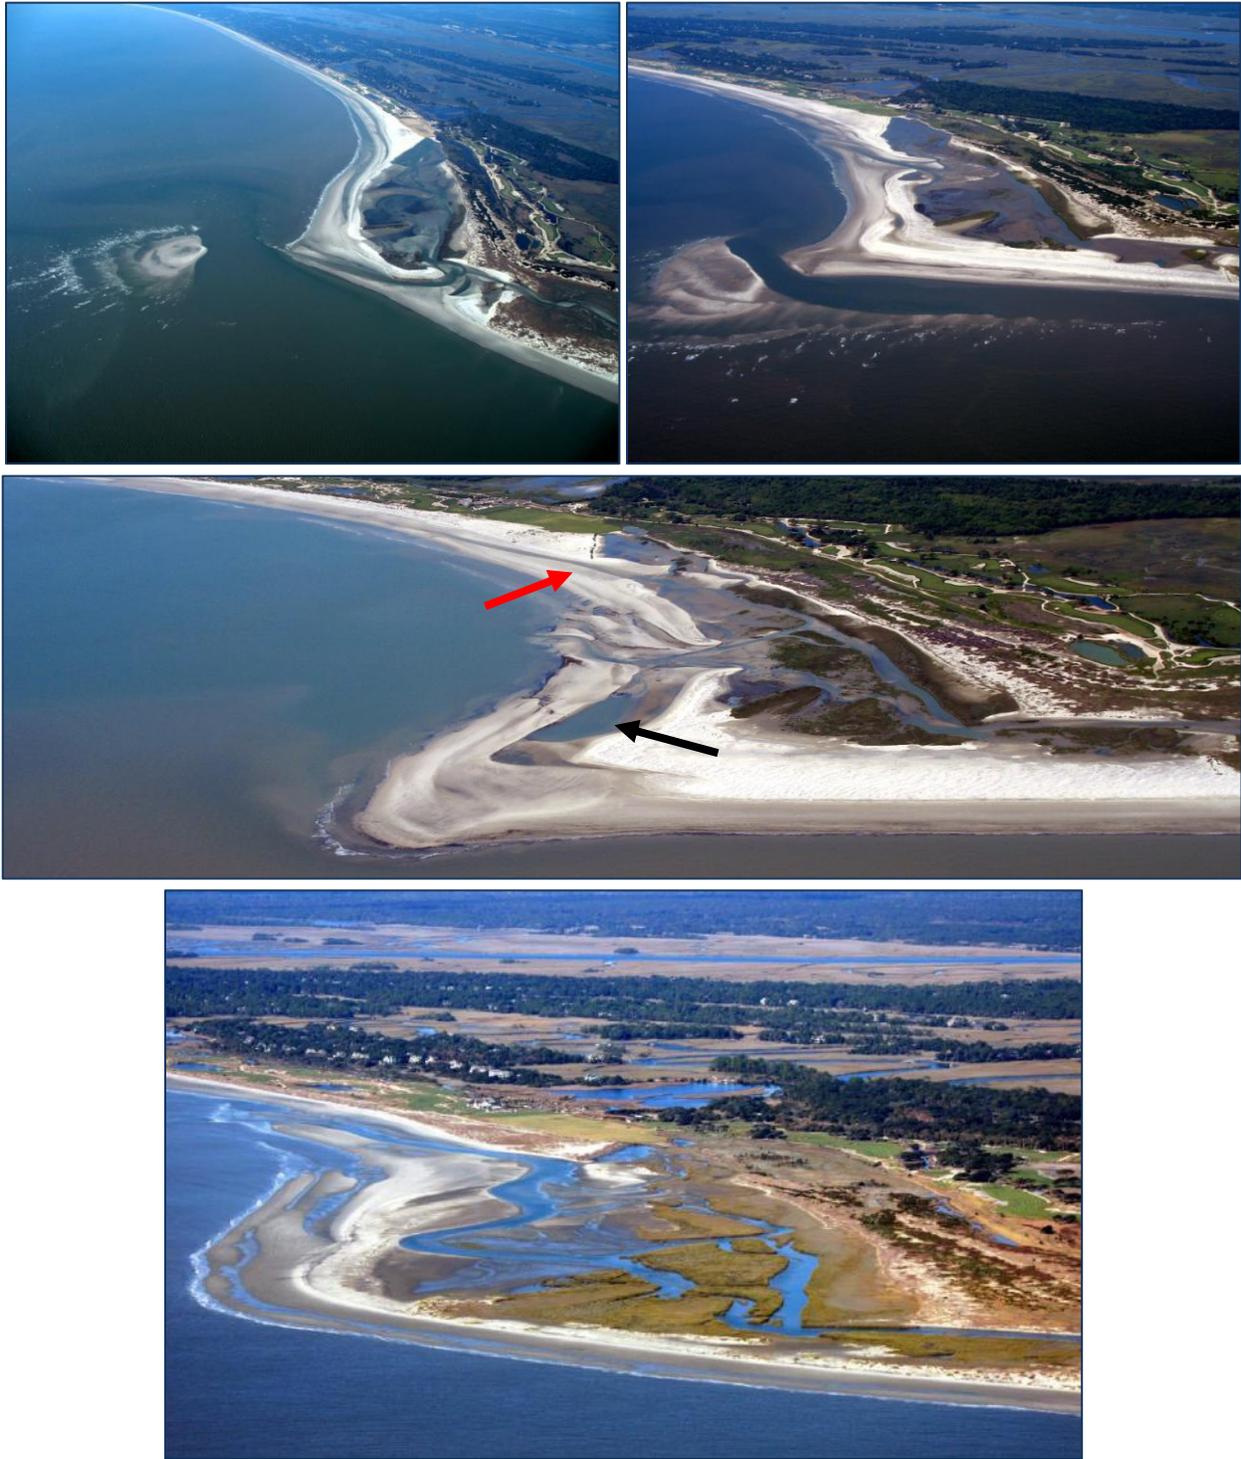
FIGURE 4.1. Oblique aerial photos of the west lagoon at the northeastern end of Kiawah Island. In December 2006 (upper left), an incipient shoal was present offshore of the eastern end of the lagoon. By May 2008 (upper right), the shoal was nearing attachment. A shoreline salient had formed on the outer barrier, as sand eroded from adjacent areas was deposited behind the shoal. The flushing channel had also relocated to the west and migrated westerly into the closure dike. The shoal had attached by April 2010 (middle), creating a small lagoon (black arrow) seaward of the original outer barrier. The flushing channel again relocated from the closure dike area (red arrow) to the central portion of the lagoon. Erosion of the shoal attachment site and downcoast spreading of sand rounded off the point of land from 2010 to November 2013 (bottom). A new shoal has emerged and was nearly attached to the beach in October 2014 in a similar location as the previous shoal (see Fig 4.2). Note formation and expansion of salt marsh in the west lagoon over the seven-year period represented by the photos.

Rapid and large-scale volume changes led to closure of the original (constructed) flushing channel and the opening of a new channel in the summer of 2007 (cf — Fig 2.6). The new flushing channel was located near the center of the west lagoon and migrated west between 2007 and 2009. It began to encroach on the constructed dike as it continued to migrate west. During this time (2007–2009), the outer barrier eroded via overtopping and sand spreading to the lee of the shoal, leaving it low, narrow, and susceptible to another breach. A new breach occurred between August 2009 and April 2010, and the old channel closed naturally. The new inlet was again located near the central portion of the west lagoon near the attachment site of the western edge of the incipient shoal. The seaward end of the channel meandered between 2010 and 2012; however, the channel throat remained in the same general location. The channel migrated further west from 2012 to 2014, encroaching on the 2006 closure dike and emptying in front of the Ocean Course clubhouse. Migration of the channel accelerated in late 2014.

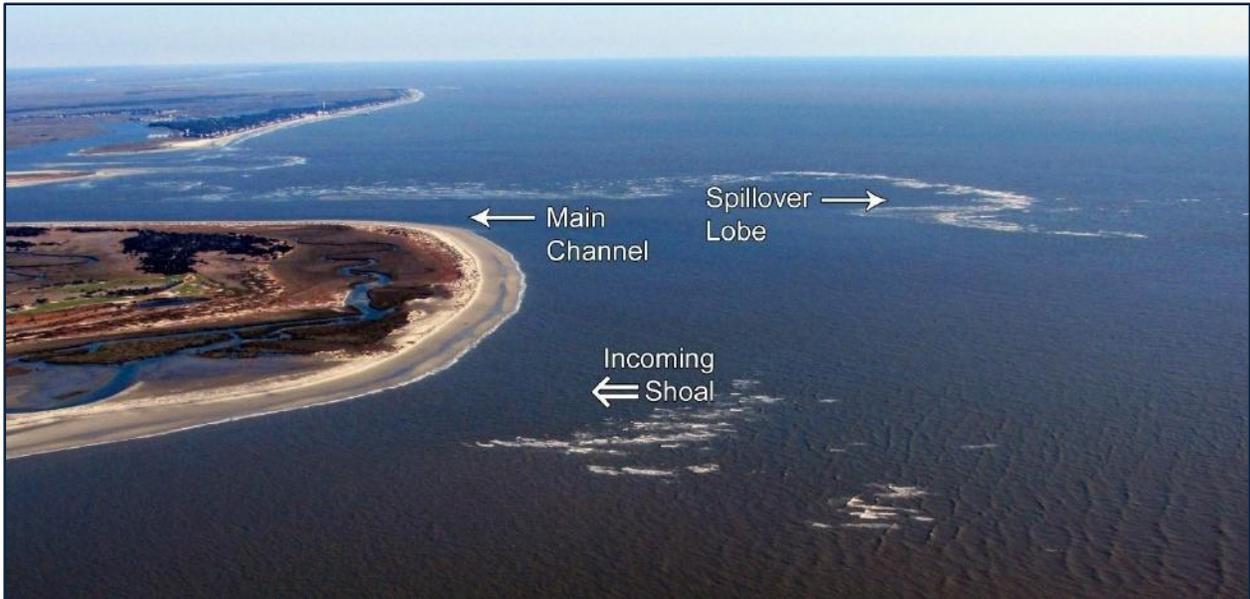
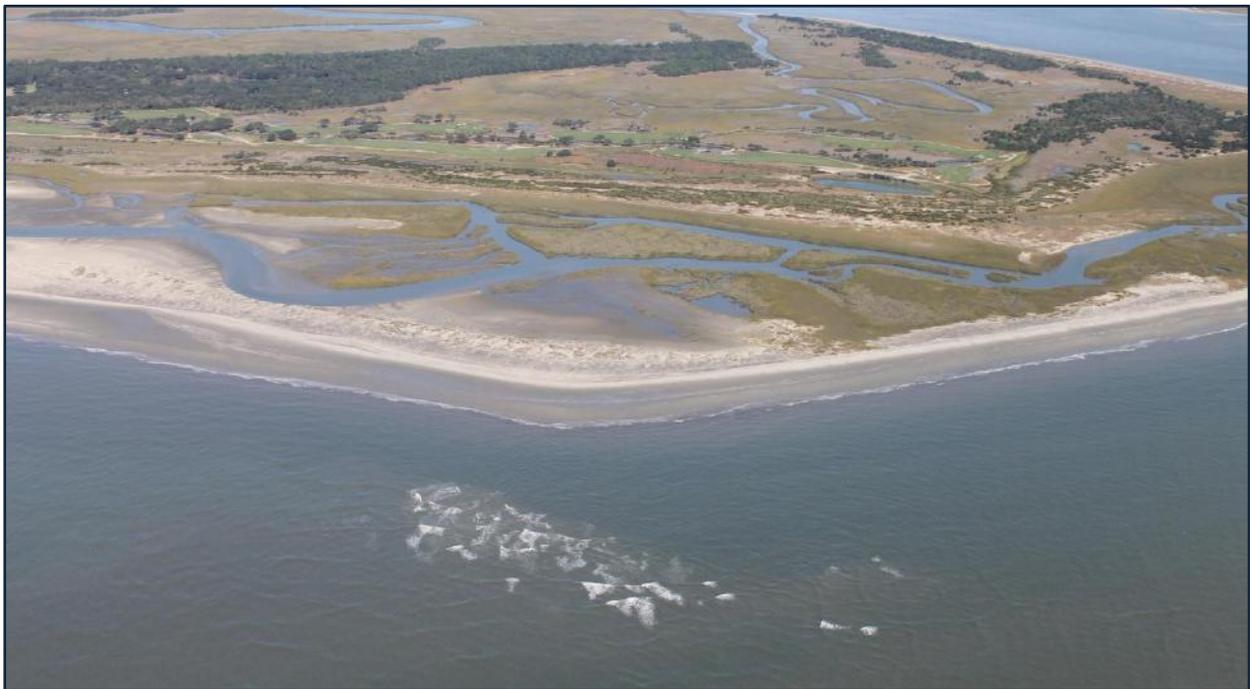
FIGURE 4.2. Seaward aerial view of the Stono Inlet delta in November 2013 (upper) and landward aerial view in October 2014 (lower).

Two significant, but related, events have occurred in the project area since construction. The first was formation and emergence of an inlet shoal near the southern apex of the bulge created by the previous bypassing events (Fig 4.1). This shoal followed the typical shoal-bypass progression, reaching Stage 3 in 2010. While in Stage 2, the breakwater effect of the shoal contributed to severe erosion of portions of the outer beach adjacent to the shoal while accretion occurred in its lee. The attachment site eroded after attachment in 2010, contributing to gains in adjacent areas consistent with Stage 3 of the bypassing cycle (cf — Fig 2.6). A new shoal is nearly attached to the beach (Fig 4.2) in a similar location as the 2010 shoal.

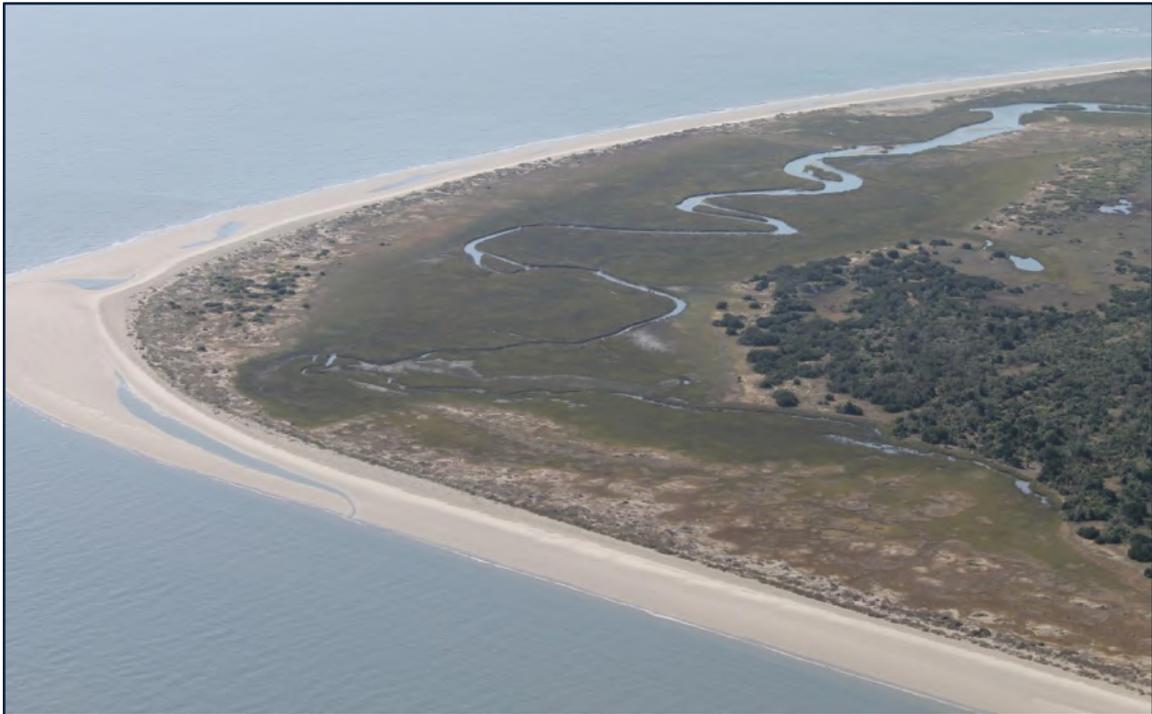
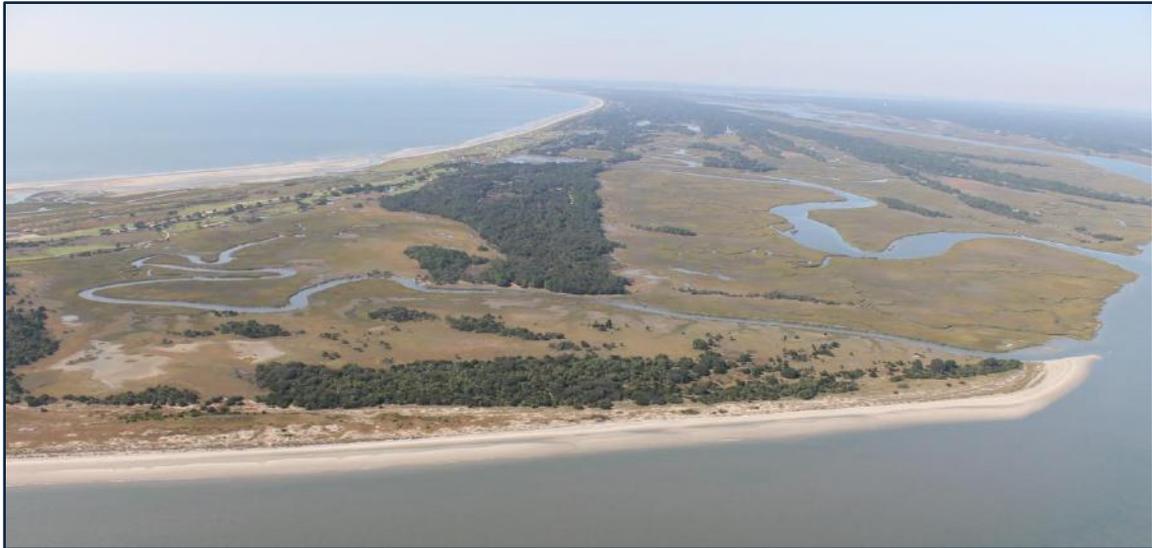
FIGURE 4.6. October 2014 aerial images of the Stono Inlet reach which eroded more over the past year than during any other interval since 2007. This has led to escarpments along most of the reach.

Aerial images from October 2014 are shown in Figure 4.6. Along the majority of the reach, there is little stable dry beach and evidence of a recent escarpment. The escarpment is visible in the distinct vegetation line in the photographs. The condition of the shoreline along Stono Inlet Reach is mostly influenced by sand moving landward from the area fronting the lagoon further west. Insufficient sand supply is coming from the eastern lagoon area (seaward of the Stono River shoreline), which was highly erosional over the past year. The erosion is caused by sand overwashing into the lagoon as well and sand moving to the west due to a shoal-bypass event presently occurring. This will be discussed in detail in the next section.

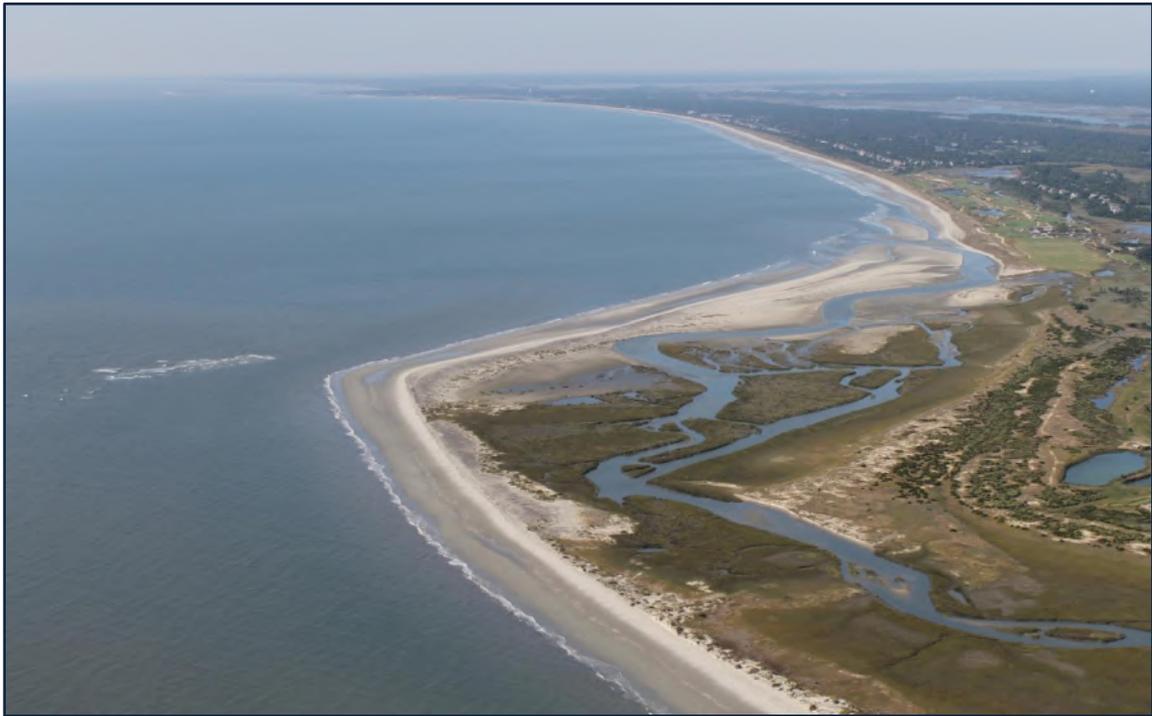
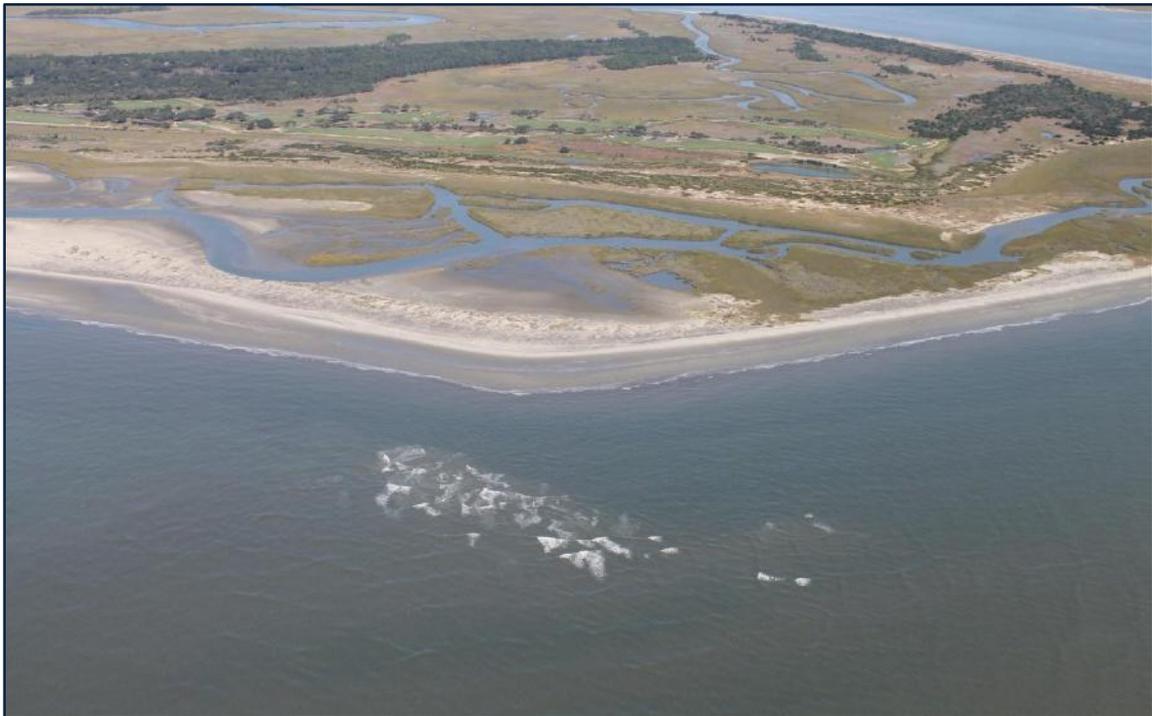
FIGURE 4.7. October 2014 aerial images of the Lagoon Reach. The lower photo shows the position of the approaching shoal.

In 2012, the incoming shoal was positioned ~1,700 ft from the beach and was still far enough offshore to only have limited impacts to the beach. Between 2012 and 2013, the shoal migrated ~700 ft (Fig 4.) landward. At the same time, the low-tide beach (at 0 ft NAVD elevation) in the lee of the shoal built out ~100 ft. Between October 2013 and October 2014, the shoal migrated ~500 ft landward. The elevation of the shoal grew to approximately -4 ft NAVD, compared to -6 ft in 2012 and 2013. The leading edge of the shoal is closest to the beach near Line 50, where it was ~450 ft from the beach in 2014 (see Fig 4.7, lower).

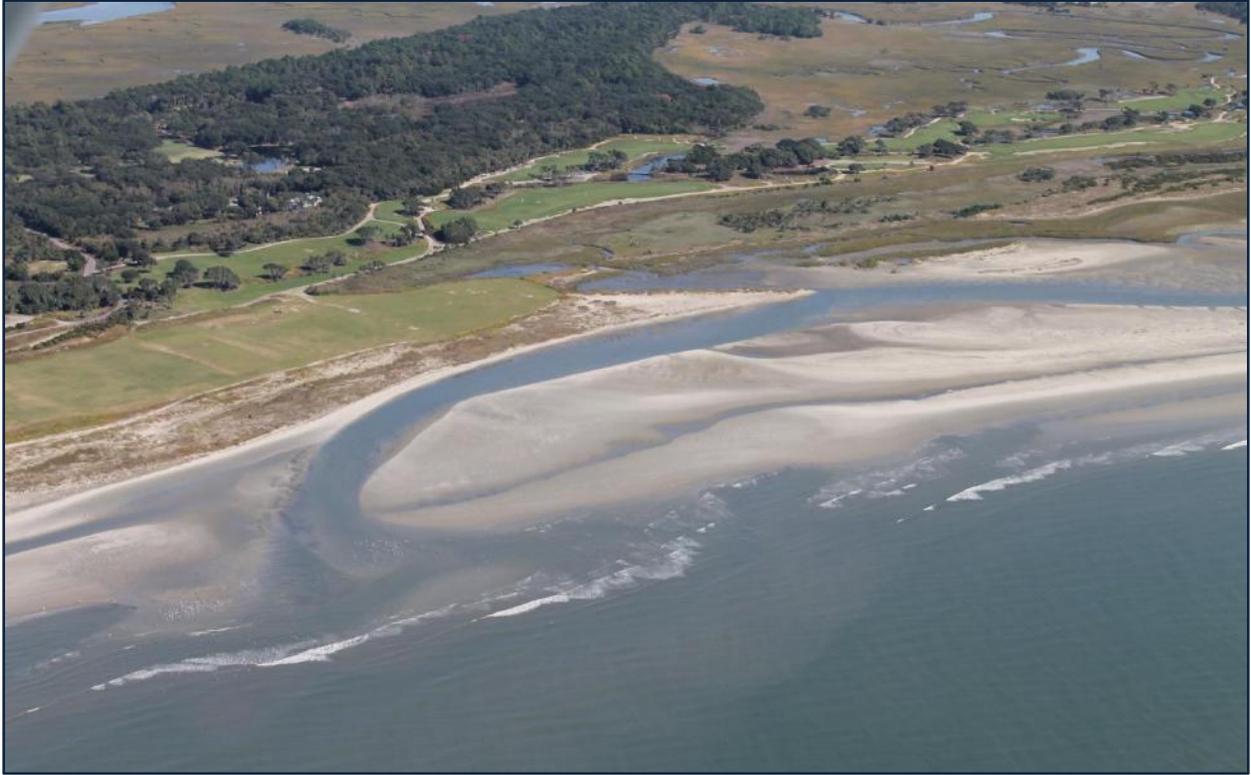
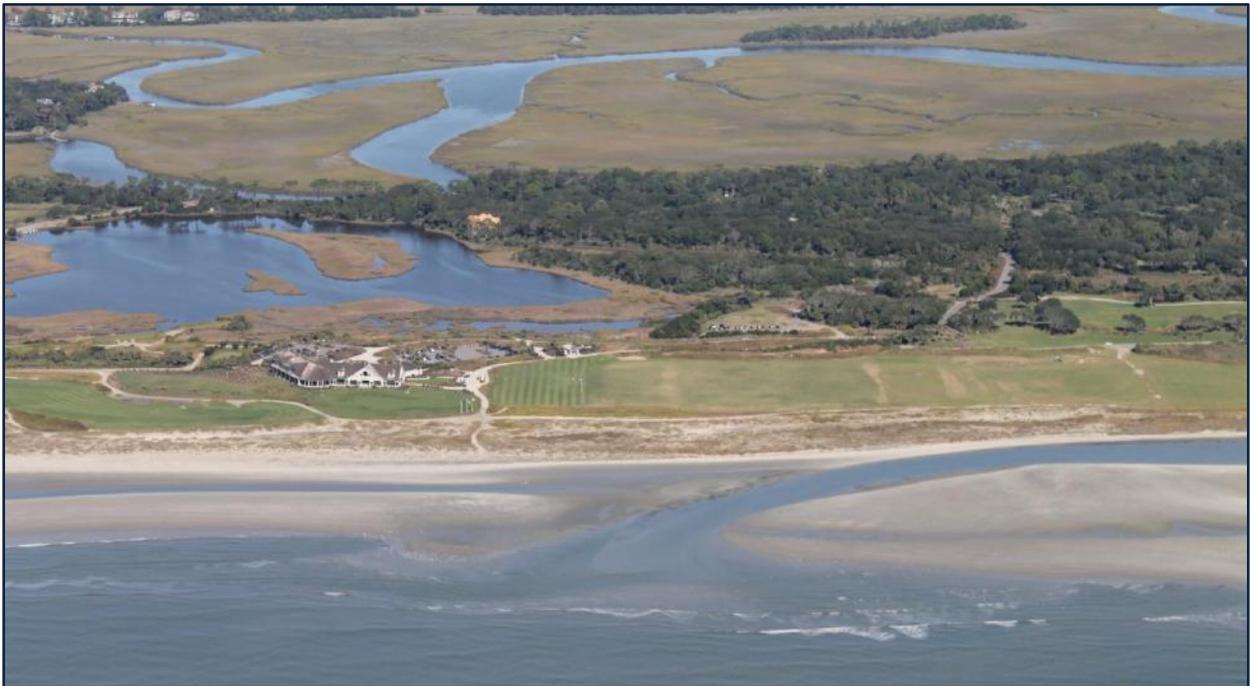
FIGURE 4.9. October 2014 aerial images of the lagoon flushing channel. The channel rapidly migrated into the dune area and driving range after these images were taken.

As discussed in the previous monitoring report, the lagoon flushing channel has migrated westward to the point where it is threatening dunes and infrastructure of the Ocean Course. Between October 2013 and October 2014, the seaward end of the flushing channel migrated westward, paralleling the beach along the east end of the driving range before deflecting seaward just east of the driving range tee box (Fig 4.9). At line 46, near the center of the driving range, the channel migration resulted in ~250 ft of dune erosion from 2013 to 2014, the majority of which occurred between October 2013 and April 2014 (Fig 4.10).

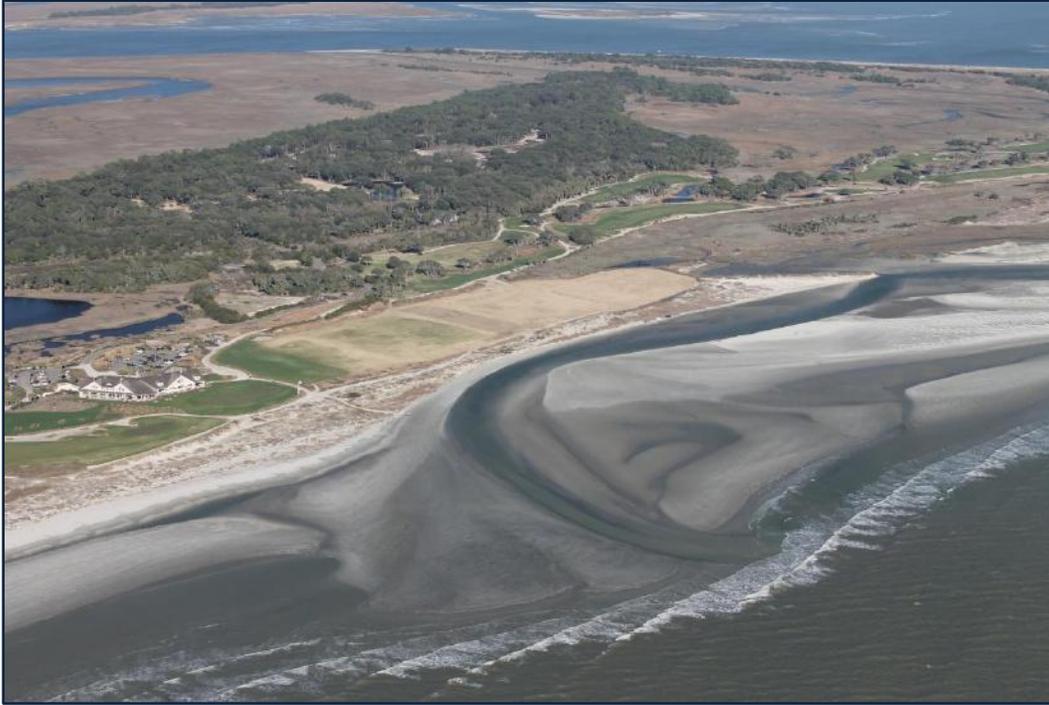
FIGURE 4.11. Aerial image from January 2015 showing additional encroachment of the flushing channel.

At the same time, intertidal shoals seaward of the channel continued to build, reaching over 1,000 ft in width seaward of the channel near line 45. Sandbags were installed by the Kiawah Island Golf Resort in February 2015 to prevent further migration of the channel into the golf course.

[A channel realignment project was completed in May–June 2015 to relocate the flushing channel to a position near Line 50 and eliminate the erosion occurring in the dune area fronting the Ocean Course. The details of this project will be provided in an independent report to the Town in the fall of 2015.]

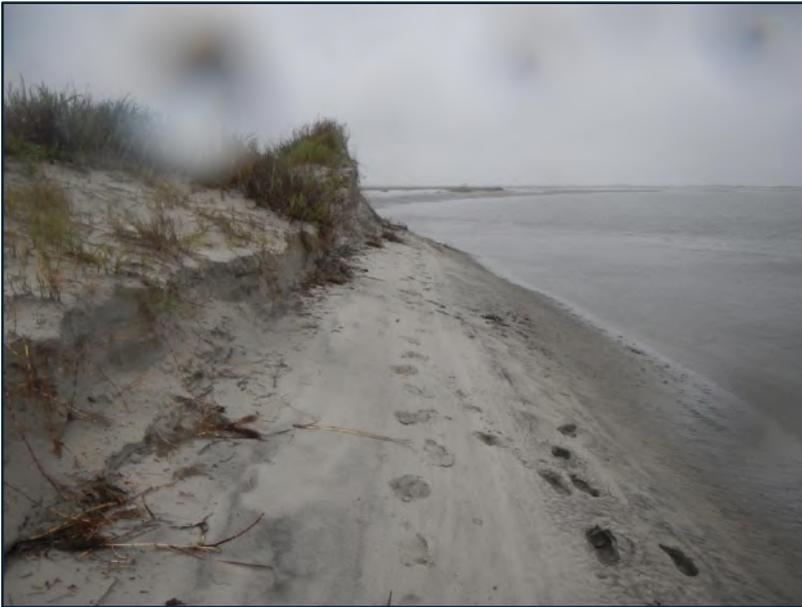
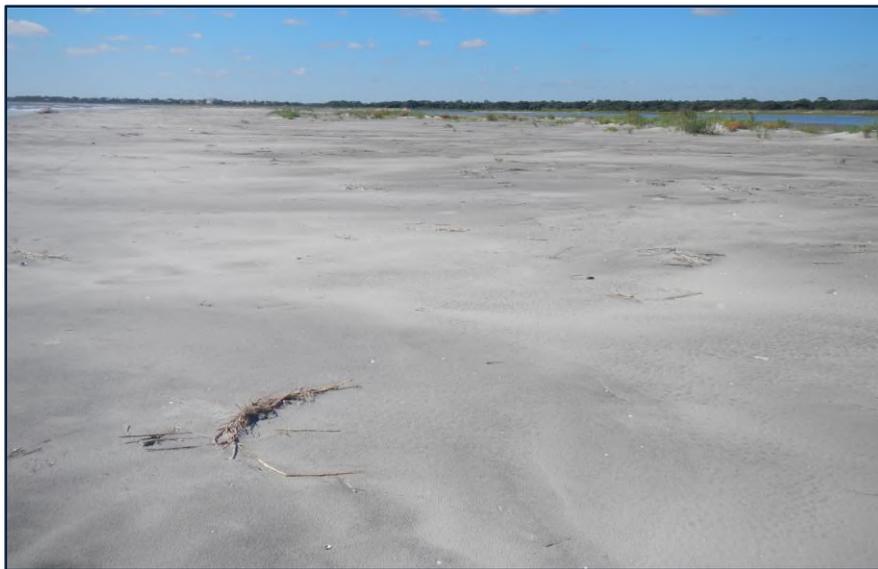
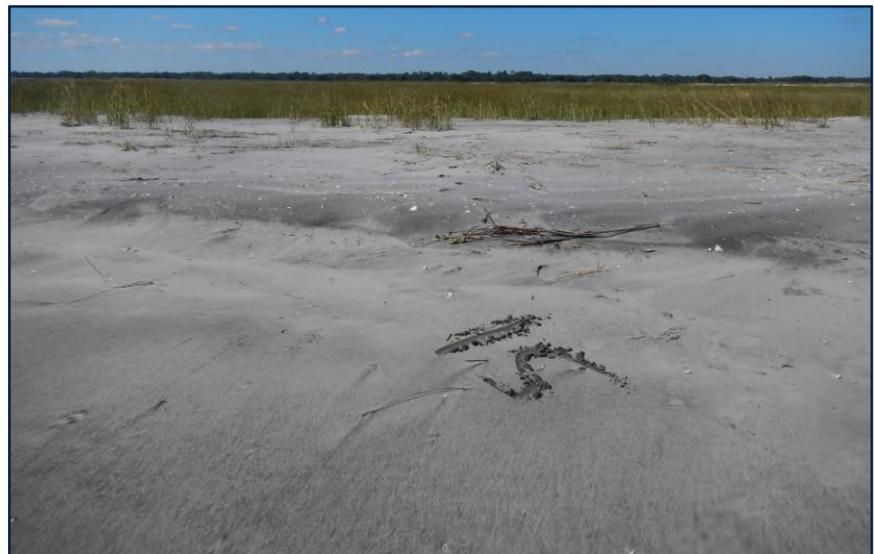
FIGURE 4.13.

October 2014 ground photos.

At Line 47, which intersects the 2006 closure dike, the channel migration eroded nearly 200 ft of dunes, however, the intertidal area built higher and wider resulting in a net gain of 144 cy/ft. The position of the outer berm was stable or accretional between Lines 47 and 50 (Fig 4.12), and erosional east of Line 50 with retreat of up to 200 ft at Line 52 (Fig 4.13).

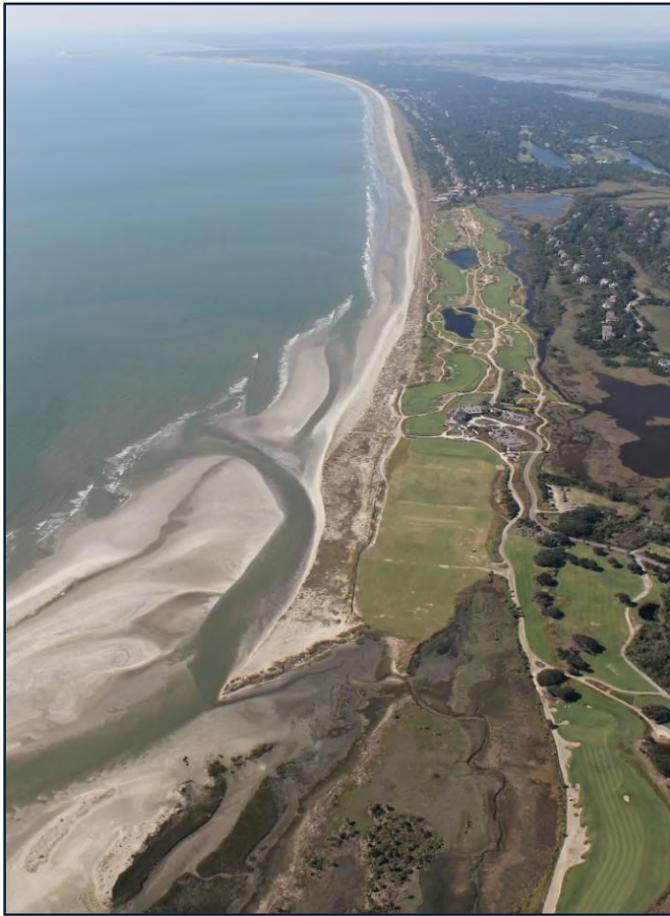
FIGURE 4.14.

The Ocean Course Reach in October 2014.

The dune field fronting the Ocean Course west of the clubhouse has continued to grow since the 2006 project.

Ocean Course Reach is the most westward reach in the project area. This transition zone, between the washover/lagoon reaches in the project area and the developed sections of Kiawah Island, contains a more typical beach profile away from the influence of Stono Inlet. Comparative profiles are, therefore, more applicable for estimating volume changes at specific locations. The reach spans 9,000 ft of shoreline, fronting the Ocean Course from Line 38 (project station 0+00) to Line 47 (project station 92+00) (Fig 4.14). It received the majority of the nourishment fill in the 2006 project.

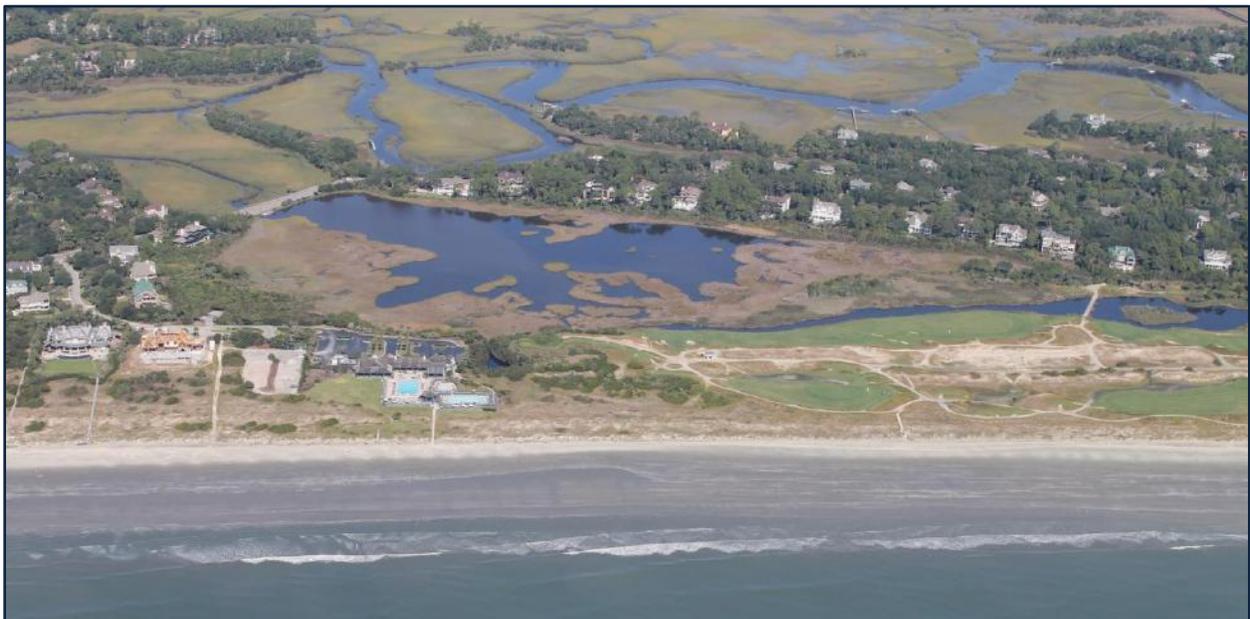
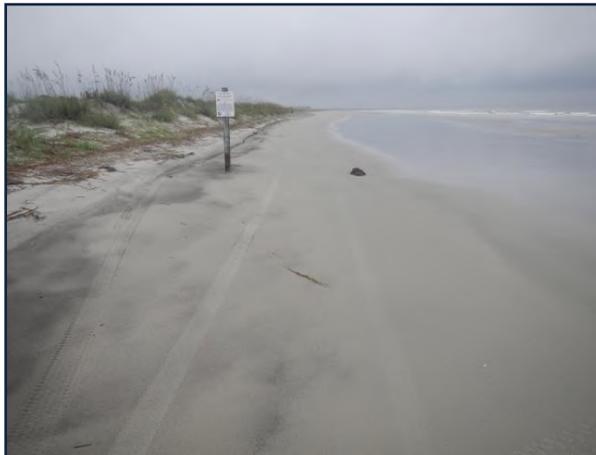
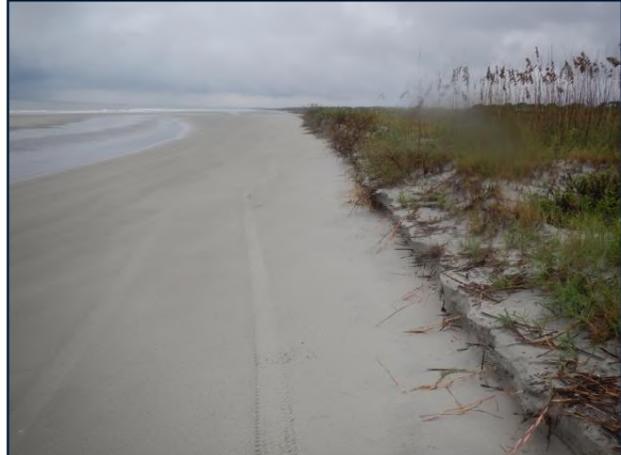
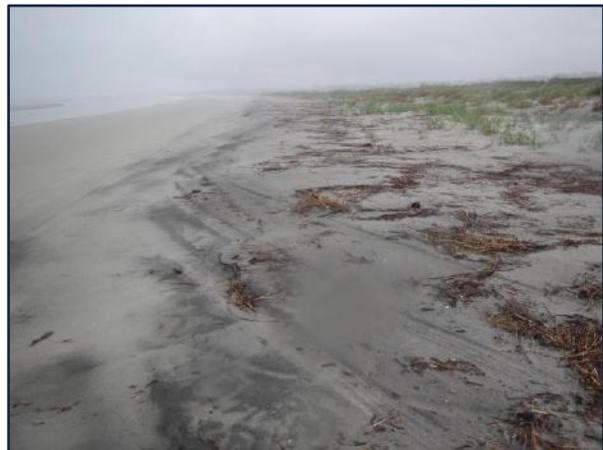
FIGURE 4.15.

Graph presents unit volumes for profiles in the Ocean Course Reach. All stations who higher volumes in 2013 than at any other time since 2006.

[UPPER RIGHT] View west from Line 43 (Hole 17)—note escarpment.

[LOWER RIGHT] View west from Line 45 (Club House).

Unit volume change within the reach was variable between profiles and ranged from –28.5 cy/ft to +60.1 cy/ft. The eastern end of the reach was the most dynamic due to the encroachment of the lagoon flushing channel (Fig 4.15, lower). Lines 45 and 46 lost dune area or upper beach area but gained sand in the intertidal area. Line 44 was just west of the channel, in the accretional downdrift bulge typical of migrating inlets, and gained the most sand between 2013 and 2014. The remainder of the reach west of the Ocean Course Clubhouse was more stable and was out of the influence of the channel.

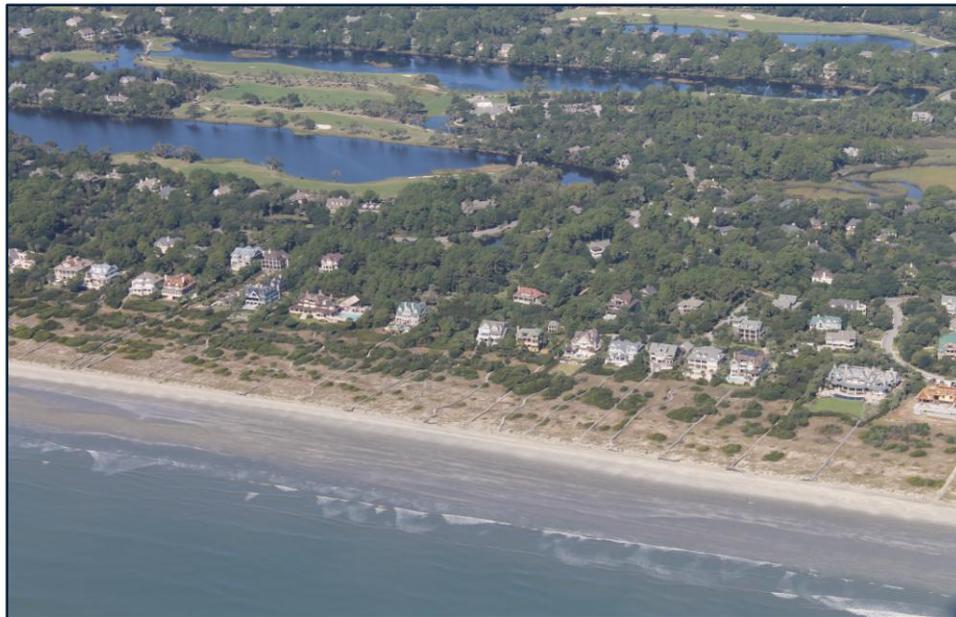
FIGURE 4.18. [UPPER] November 2013 aerial image of Turtle Point Reach. Shrub vegetation (typically waxed myrtle) continues to propagate between sparsely vegetated foredunes. CSE expects the shrub zone to expand and eventually be transformed to forest vegetation. [LOWER] October 2014 aerial image.
