**2006 EAST END BEACH RESTORATION PROJECT
KIAWAH ISLAND SOUTH CAROLINA**

**Survey Report No 8
September 2015**

SURVEY REPORT NO 8
Annual Beach and Inshore Surveys

[CSE 2392 YR8]
September 2015

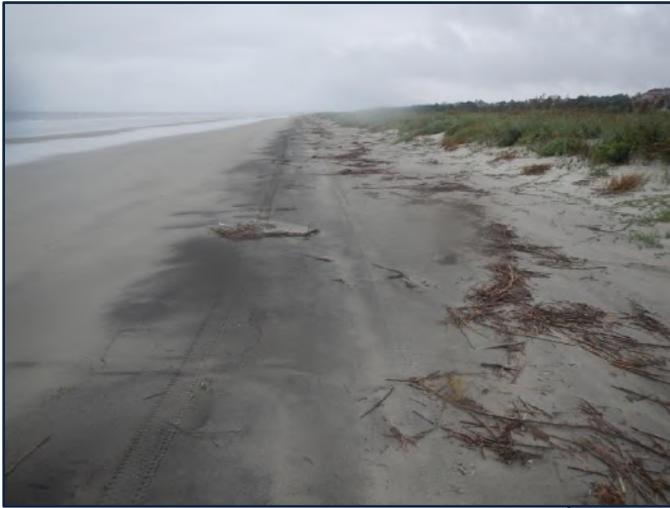
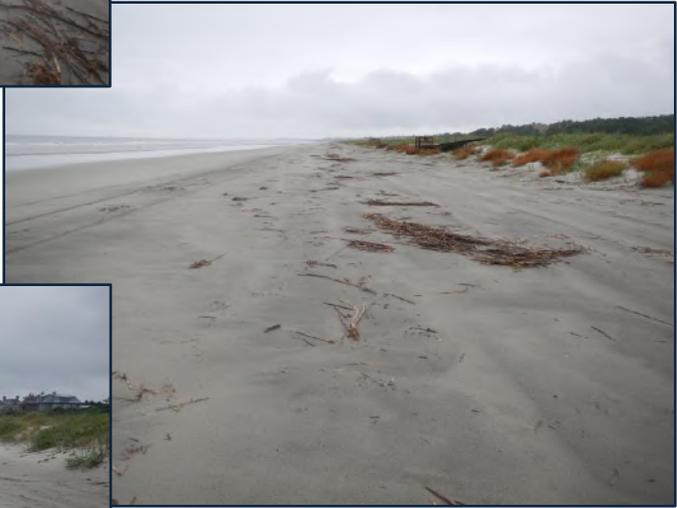
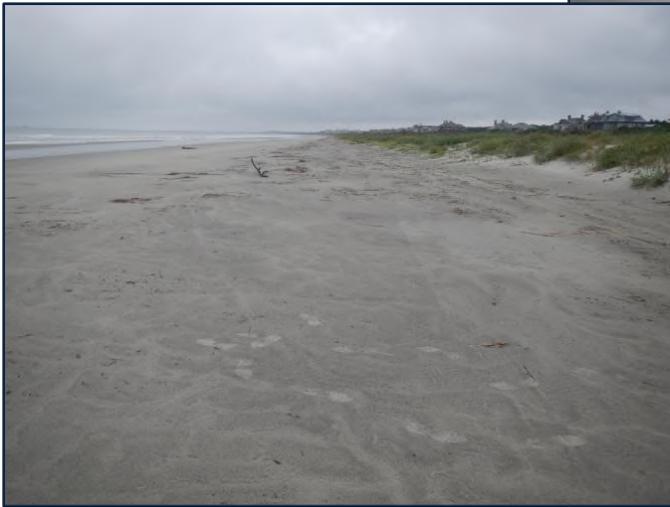
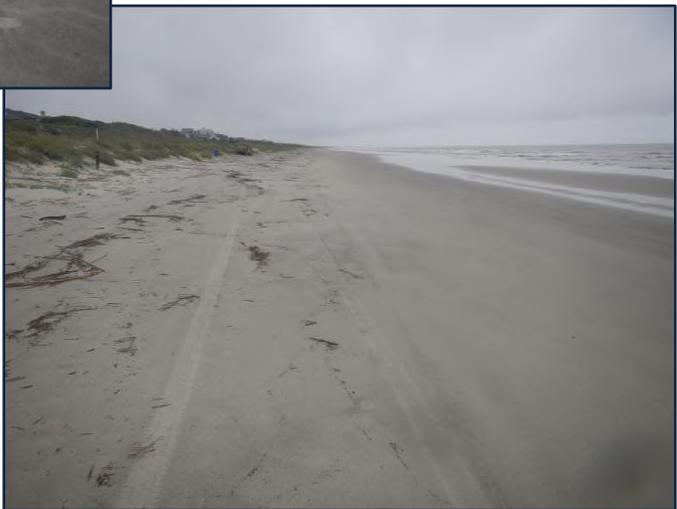
FIGURE 4.20. October 2014 ground photos of Turtle Point Reach. Note the low, wide dune field and narrow dry berm.

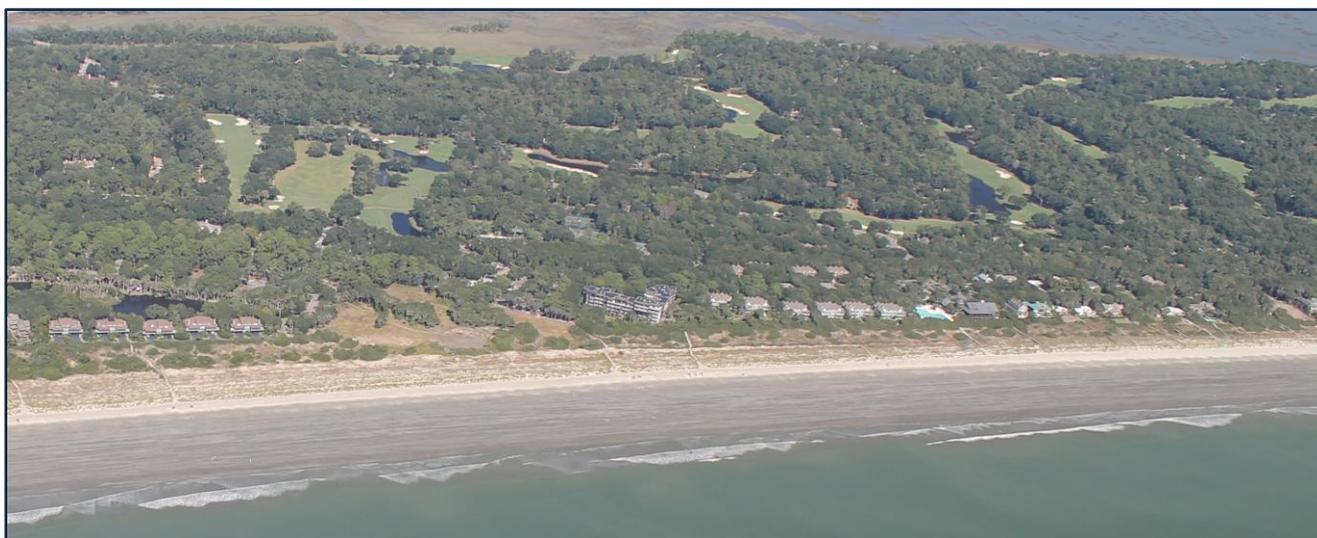
FIGURE 4.21. October 2014 aerial view of West Beach Reach.

West Beach Reach encompasses the beach between Lines 10 and 23 (Sand Alley to the 16th tee of Turtle Point Golf Club) (Fig 4.21). Historically, this reach has been fairly stable compared to remaining reaches. Although the reach has experienced periods of erosion, properties within the reach are sufficiently set back to allow for a substantial vegetated buffer between the ocean and the structures. The reach lost 3.8 cy/ft of sand from 2007 to 2008, but has accreted during every monitoring interval since then, including a gain of 3.6 cy/ft (43,000 cy) from 2013 to 2014. Lines 10, 11, and 21 lost sand over the past year, while the other ten stations gained sand. Individual stations ranged between 3.7 cy/ft erosion to 8.7 cy/ft accretion. There was no distinct trend of volume change for the various areas within the reach, but the middle portion of the reach tended to accrete more sand than the edges of the reach. Profiles show the high dune was fairly stable over the past year, and accretion was generally observed along the intertidal beach (Fig 4.22).

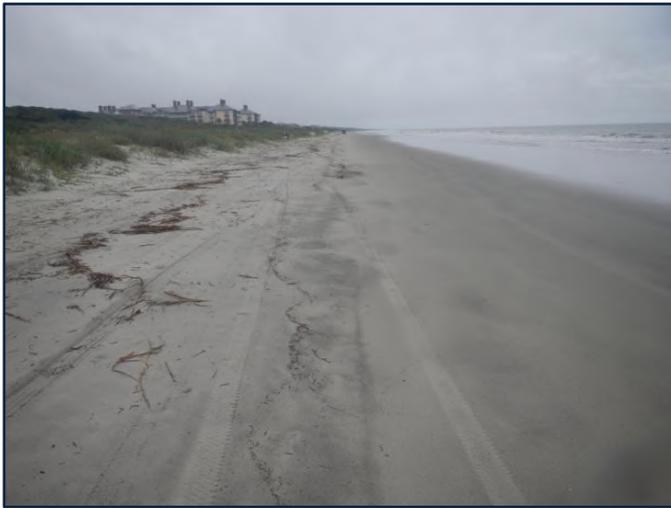
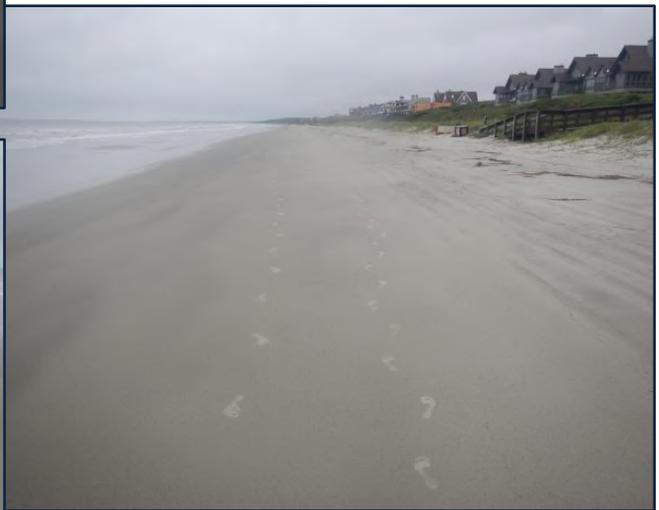
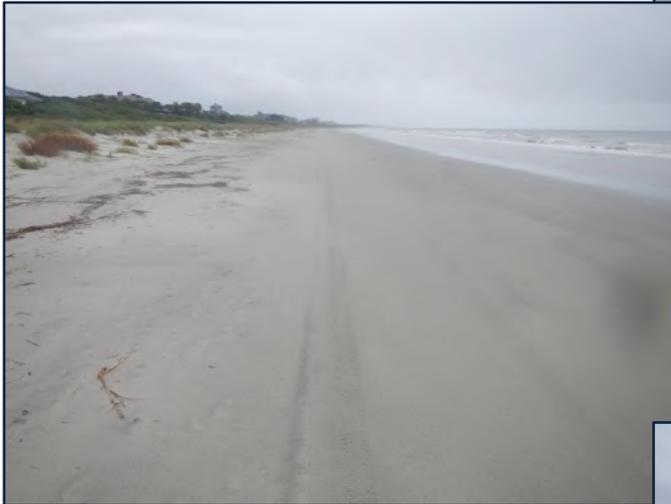
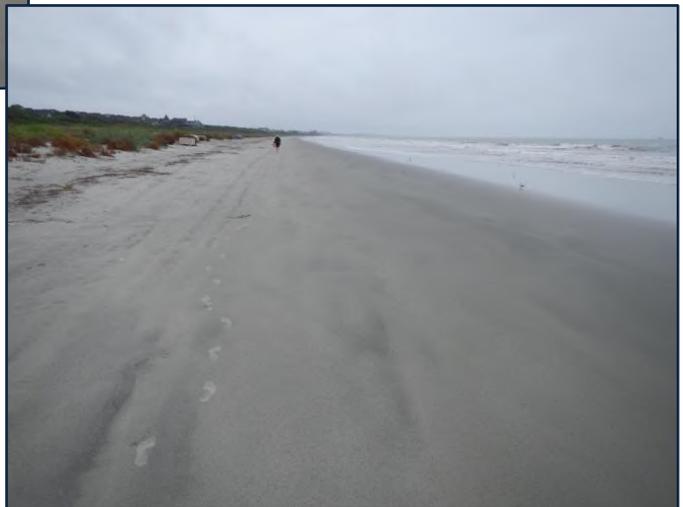
FIGURE 4.23.

Ground photos (Fig 4.23) show that the beach was stable to accretional over the past year with no escarpments present and expanding dune vegetation along the majority of the reach. West Beach Reach has historically been an area of long-term stability, with periods of erosion and accretion balancing the net sand volume change. As shown in the photos, a typical beach condition along a stable stretch of beach is a narrow dry beach fronting a growing dune. The width of the dry beach changes with the magnitude of the tide becoming smaller during spring tides and wider during neap tide cycles.

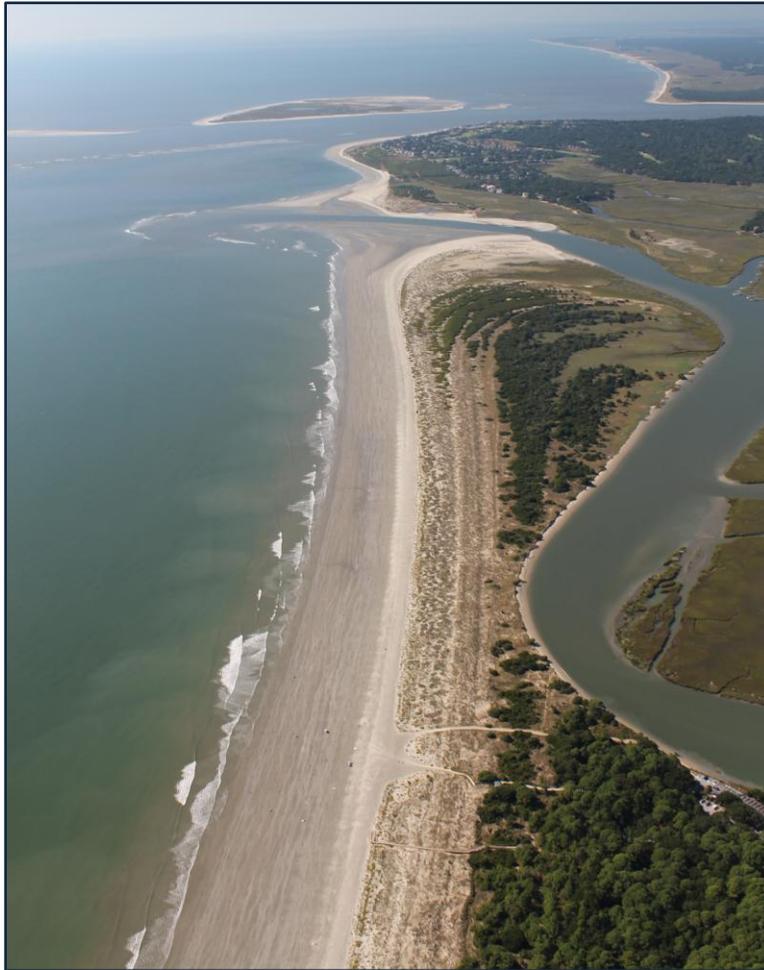
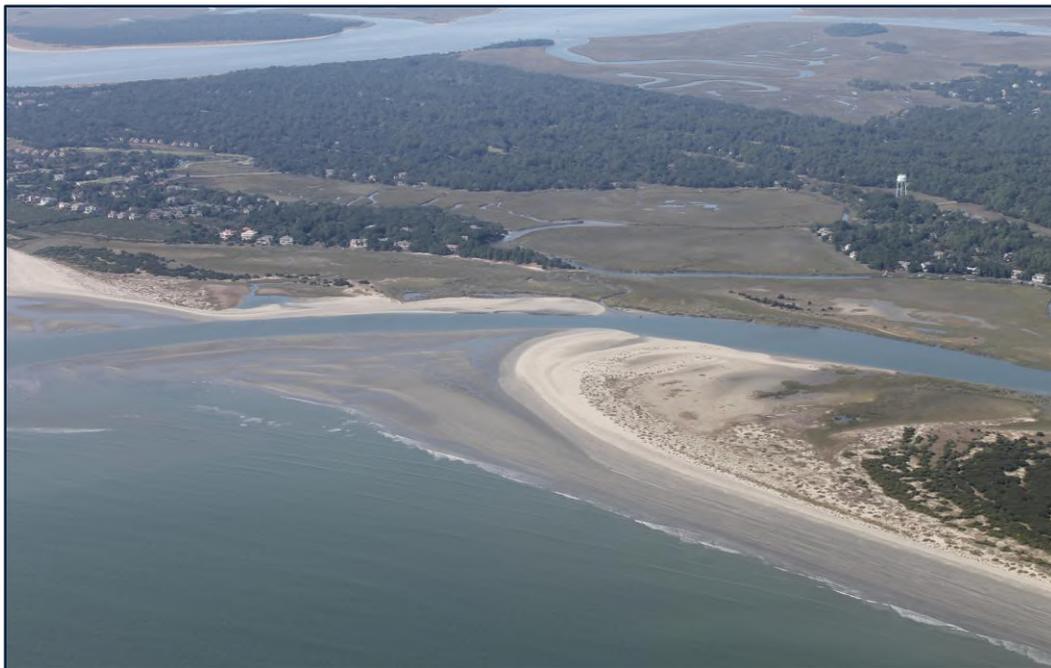
FIGURE 4.24. October 2014 aerial images of the Kiawah Spit Reach. The spit has grown seaward ~200 ft since 1999.

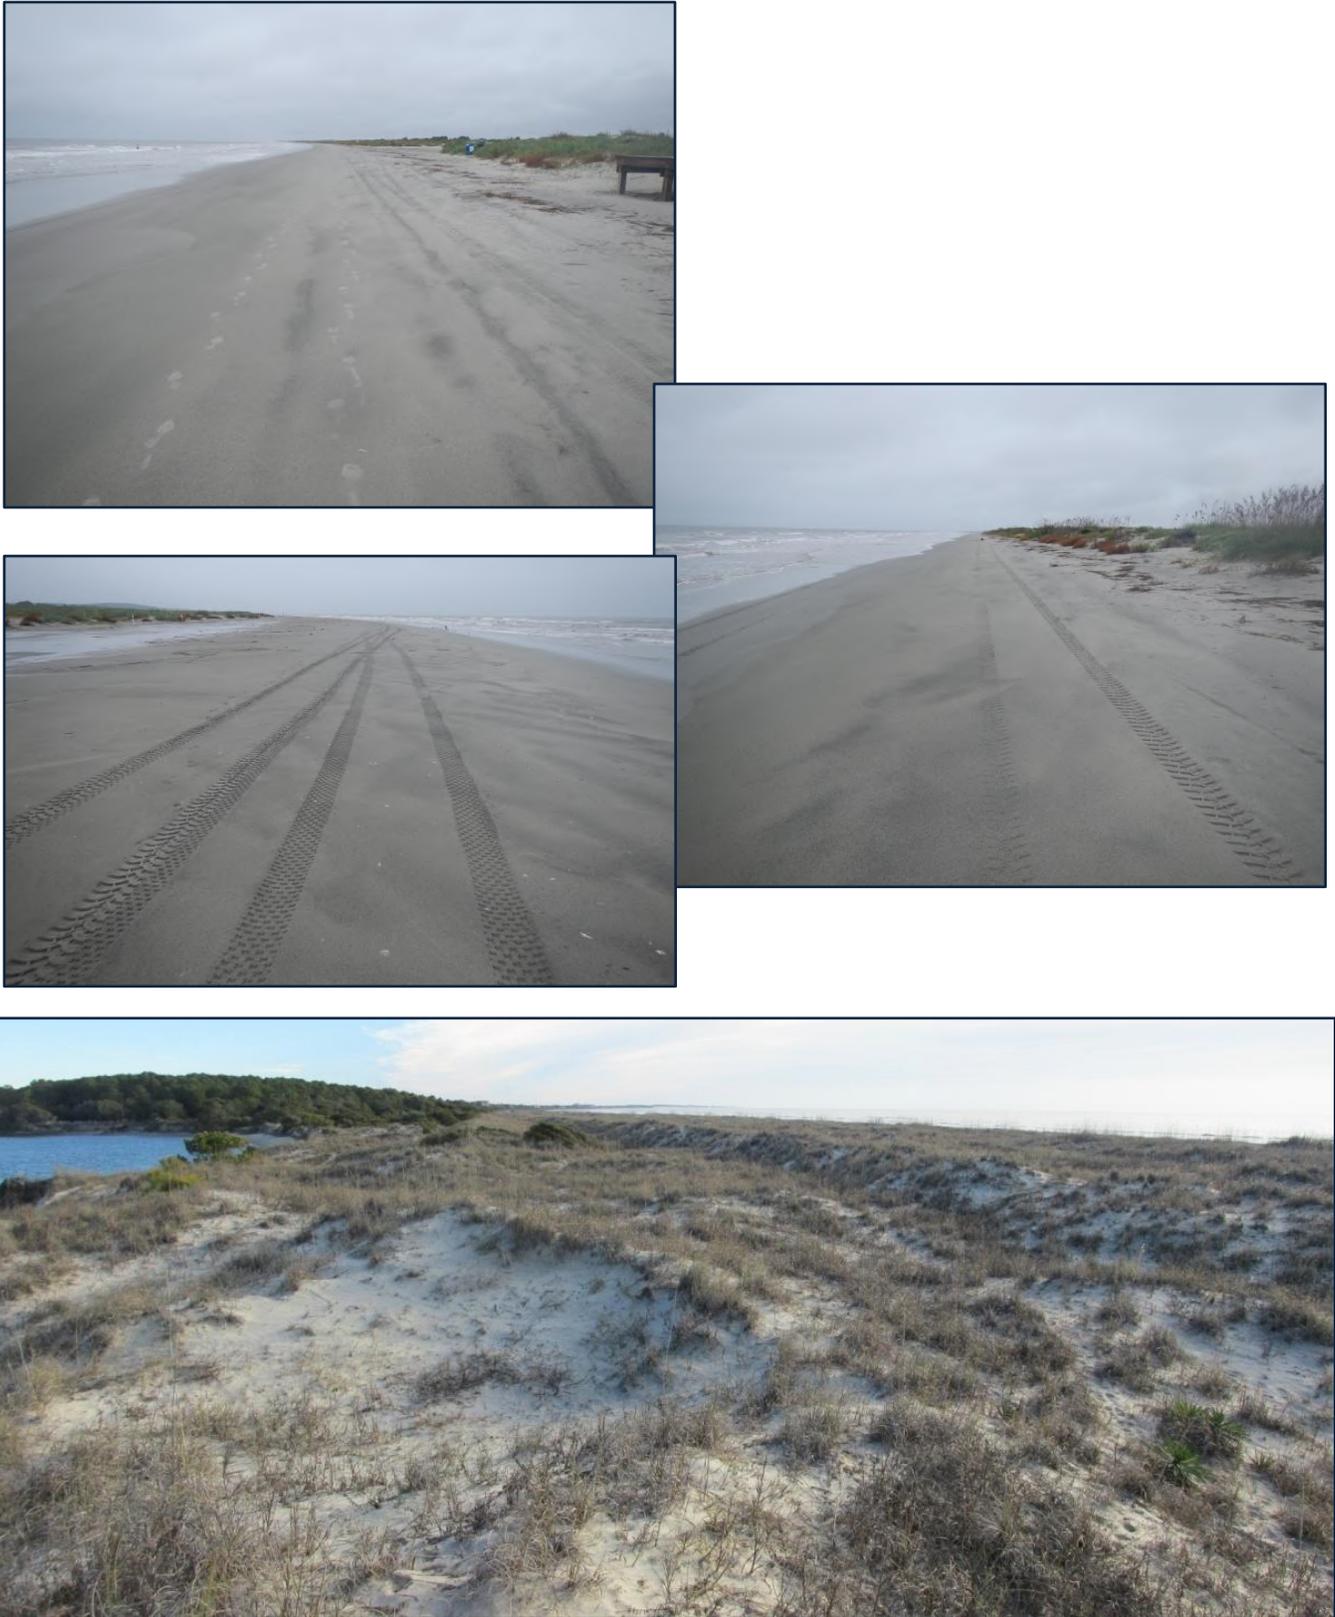
FIGURE 4.26. October 2014 ground photos of Kiawah Spit Reach. **[UPPER LEFT]** Line 8 looking west (new Beachwalker vehicle access). **[MIDDLE RIGHT]** Line 4 looking west. **[MIDDLE LEFT]** Looking east near the end of the spit. **[LOWER]** January 2014 image of the dune field just west of Beachwalker Park.
