2006 EAST END BEACH RESTORATION PROJECT
KIAWAH ISLAND SOUTH CAROLINA

2006 EAST END BEACH RESTORATION PROJECT
Kiawah Island South Carolina

SURVEY REPORT NO. 07
Annual Beach and Inshore Surveys

[CSE 232 YR 7]
February 2014

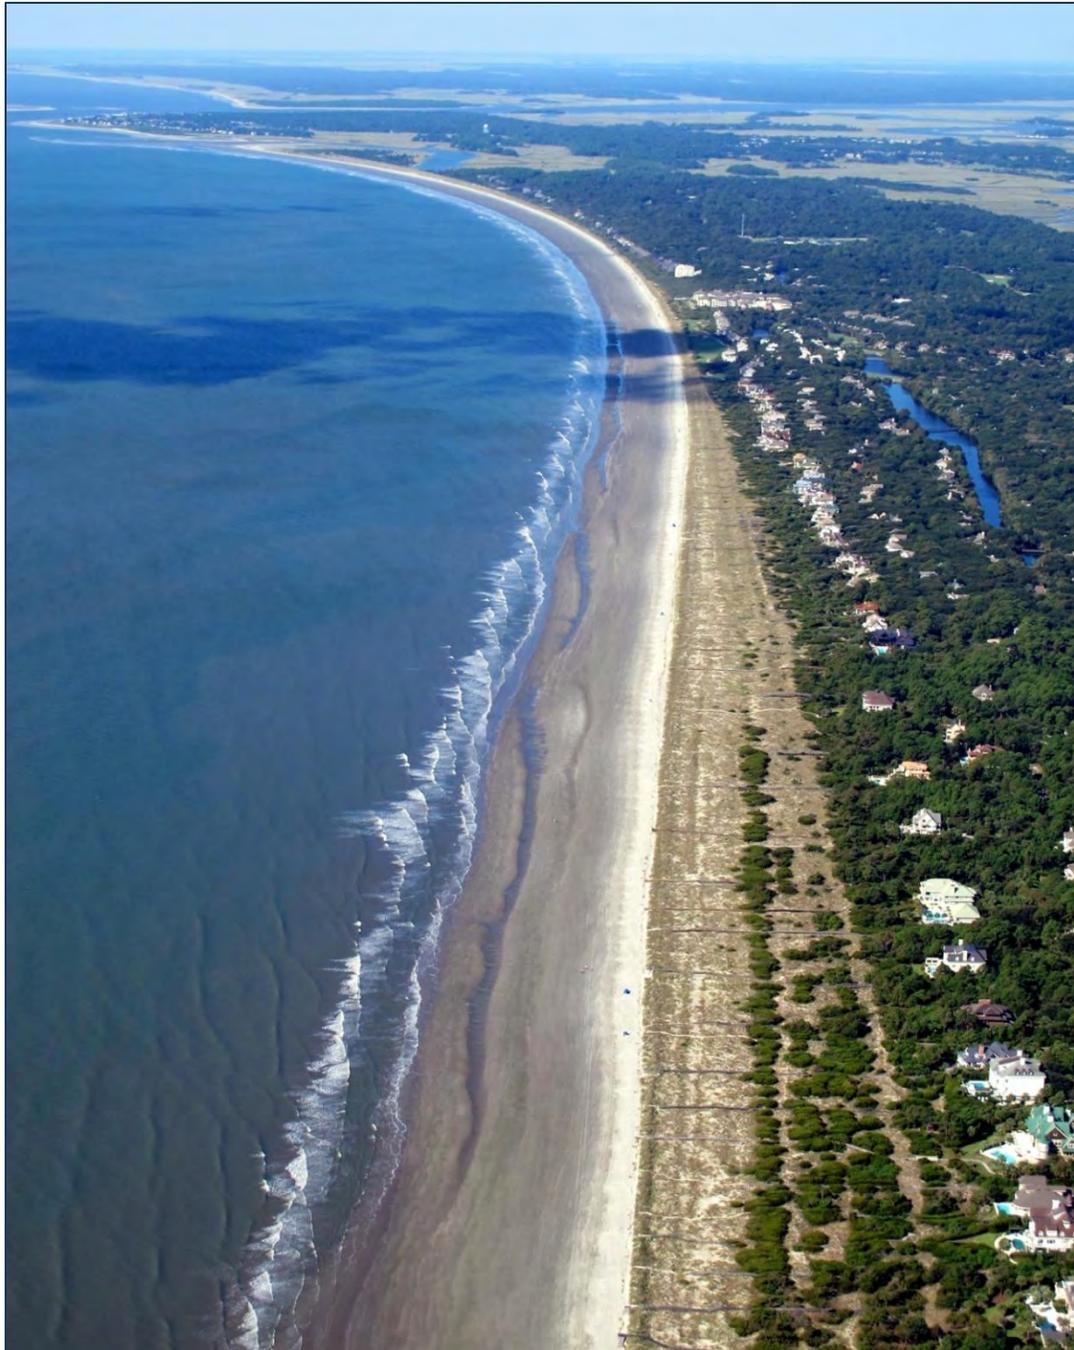
FIGURE A. Kiawah Island remains one of the healthiest beaches in South Carolina (S

Kiawah Island remains one of the healthiest beaches in South Carolina (Fig A). The results of shoreline monitoring and tracking the sand supply have provided new insight into the formation of barrier islands and rates of evolution of important habitats. Based on the results herein, the
